NERC Lessons Learned

Battery Energy Storage System
Cascading Thermal Runway

Catastrophic Failure of 345kV Oil Filled Metering Current Transformer in a Transmission Substation

Controlled Islanding due to Wildfire
Event

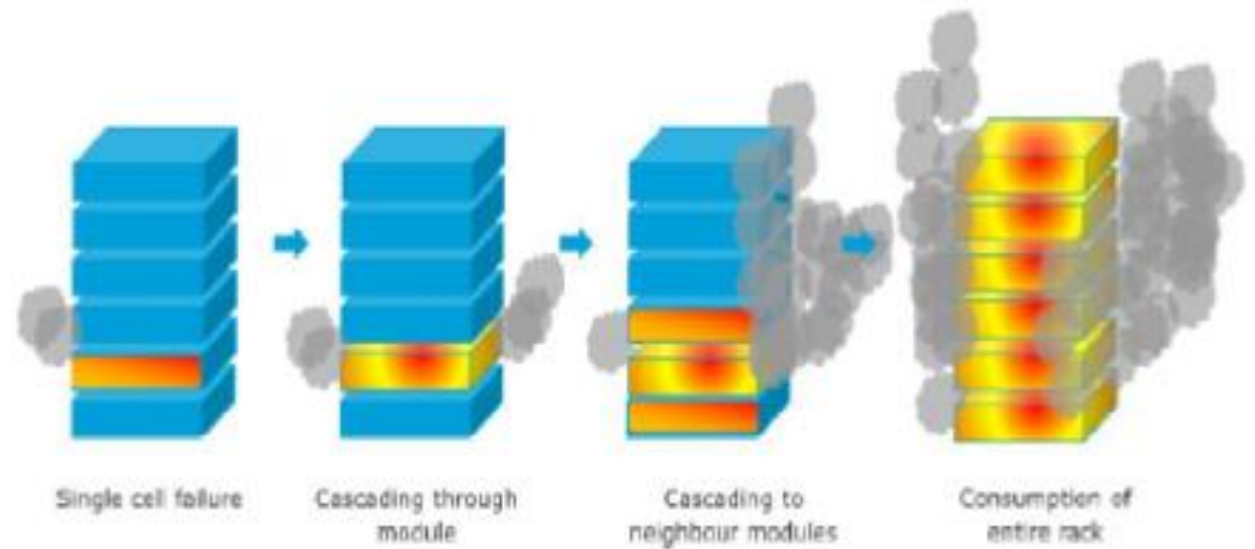
- Remote alarm triggered at 16:55 PST by fire in a BESS
- Explosion at 20:04 PST injured firefighters and significantly damaged the BESS
- Cause of fire identified as a cascading thermal runaway event
- BESS was performing a solar smoothing function
- Battery cell in the BESS experienced sudden voltage drop during charging cycle
- The thermal runaway event activated the smoke detection system and cascaded into neighboring cells and their batteries

Figure 2: A single cell failure propagated through one Module (Image credit: APS) [1]

- Improve training, emergency response planning, and procedures for first responders, operations, and maintenance personnel
- Work with suppliers, industry experts, and standards bodies to:
 - Minimize or eliminate cell-to-cell and module-to-module heat transfer to stop thermal runaway
 - Implement fire detection and suppression system designs to fully manage a thermal runaway
 - Implement design changes incorporating monitoring and remote reporting of flammable gas concentrations and implement ventilation systems to mitigate

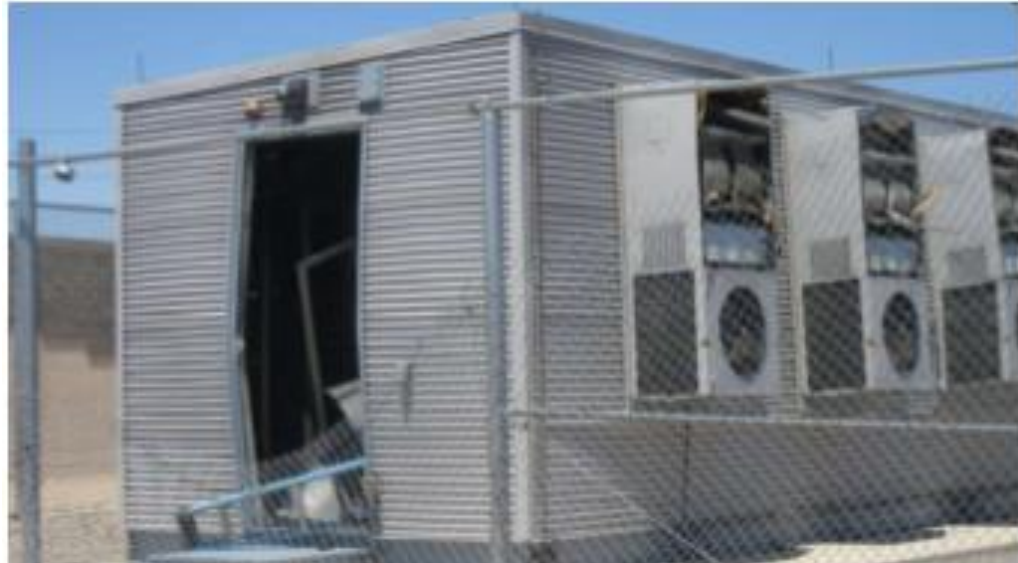
Figure 3: BESS Exterior after event (Image credit: APS) [1]

Modules 1-13 were partially melted and fused from the heat of thermal runaway.

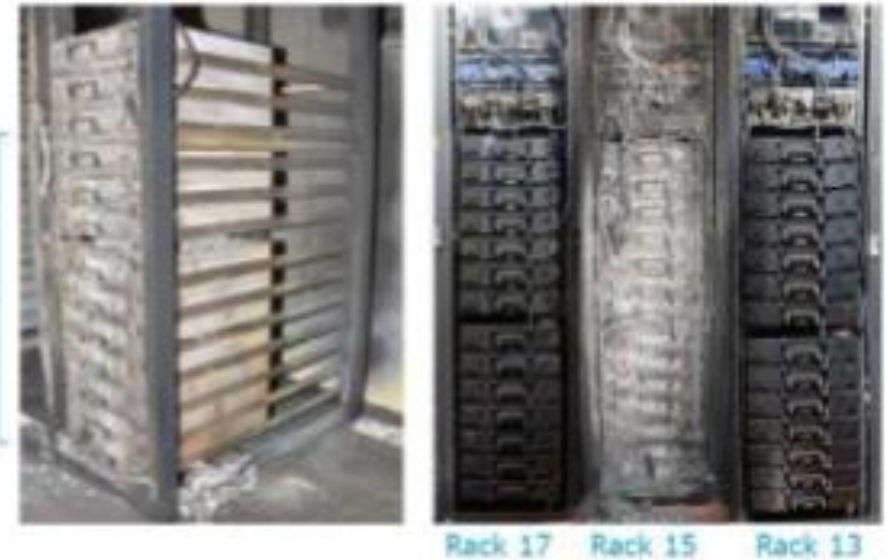
Figure 4: All modules in Rack 15 were severely damaged by thermal runaway while leaving nearby racks mostly intact (Image credit: APS) [1]

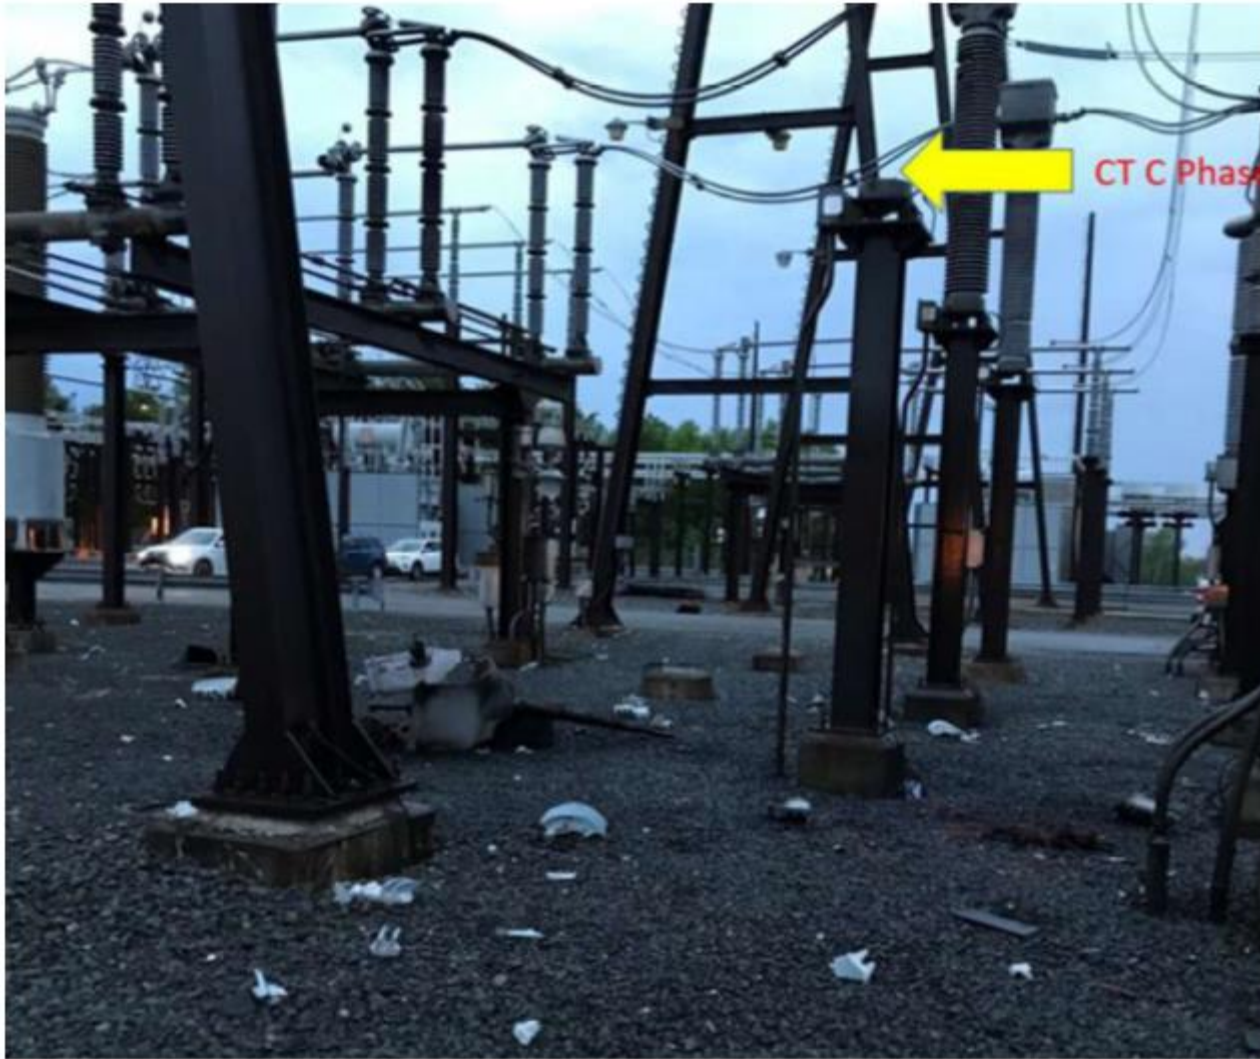
- Catastrophic failure of 345 kV C-phase transformer caused the CT to explode causing fire and spread of glass shrapnel across switchyard
- Fault also led to tripping of 345 kV South Bus, removing Capacitor Bank #2 and inverter based controlled reactive device
- 345 kV Breaker scheduled maintenance led to open-ended Line B
- Entity conducted a root cause analysis

Figure 7: Switchyard Shrapnel after the explosion [2]

- Plan was devised to replace all similar CTs
- Entity re-evaluated its maintenance and testing program
- Oil-filled electromagnetic CTs should be evaluated for removal/replacement
- Formalize industry-wide equipment lesson sharing
- Obtain better understanding of failure modes and mechanisms
- Entities should evaluate inspection, maintenance, testing steps and associated frequencies for similar oil-filled equipment
- Use polymer instead of ceramic insulators
- Consider replacement with optical CT
