# NERC Lessons Learned

Lockout Relay Component Failure  
Causes Misoperation and Reportable  
Event

Midwest Reliability Organization

July 30, 2020

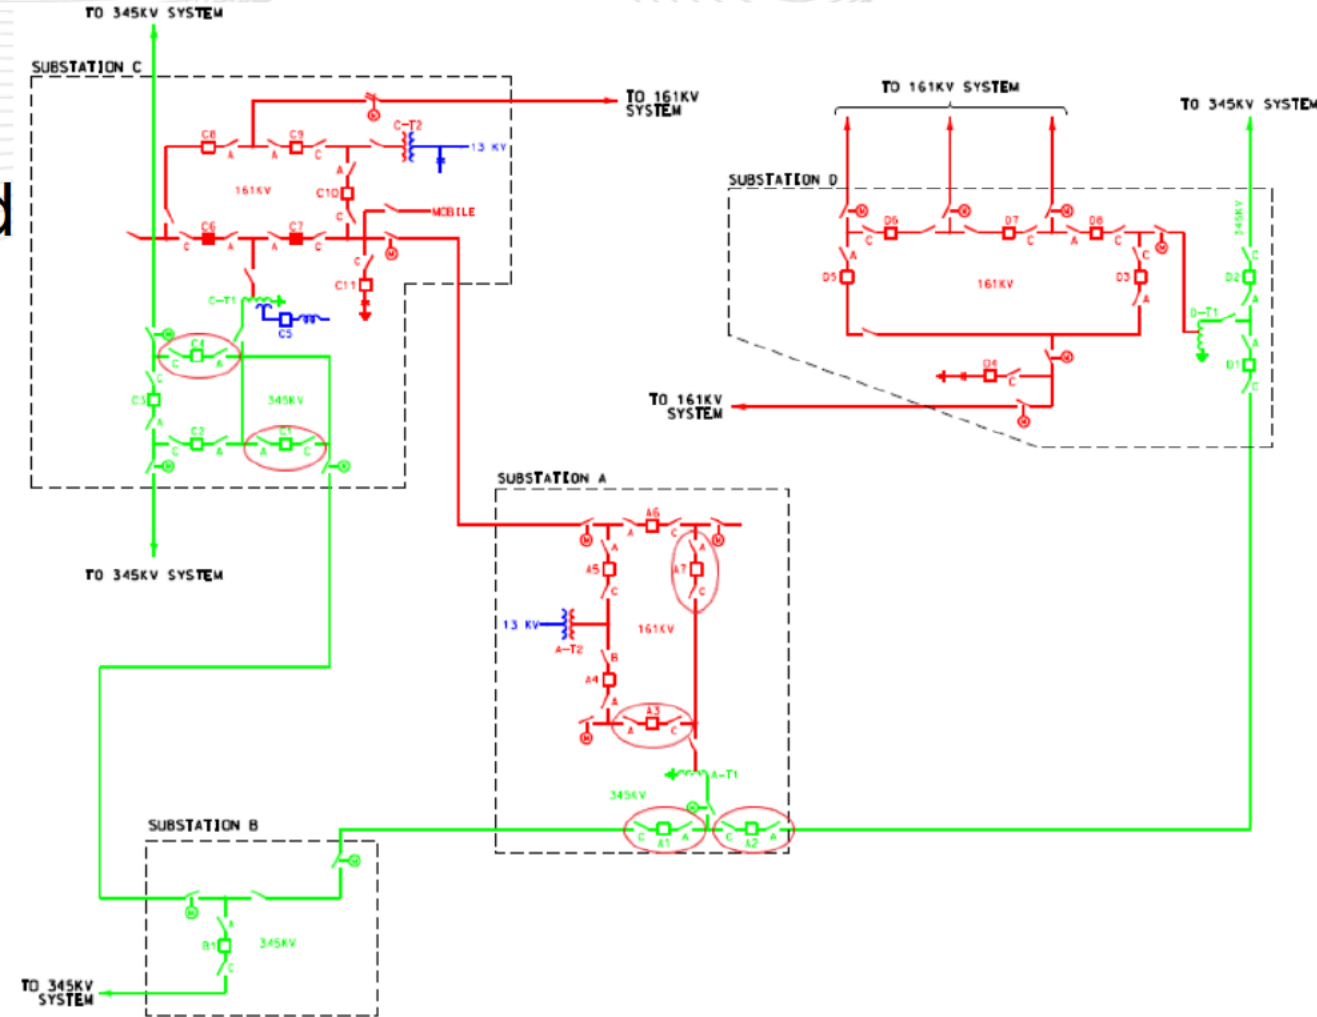
- An unnecessary trip caused BES equipment to be removed from service
- Caused by a misoperation of the lockout relay associated with a 345 kV breaker at Substation A
- Tripped (2) lines and XFMR
- A faulty lighted nameplate control circuit was found to be responsible

Figure 1: Diagram showing the breakers affected (circled) by the misoperation of the lockout relay [1]

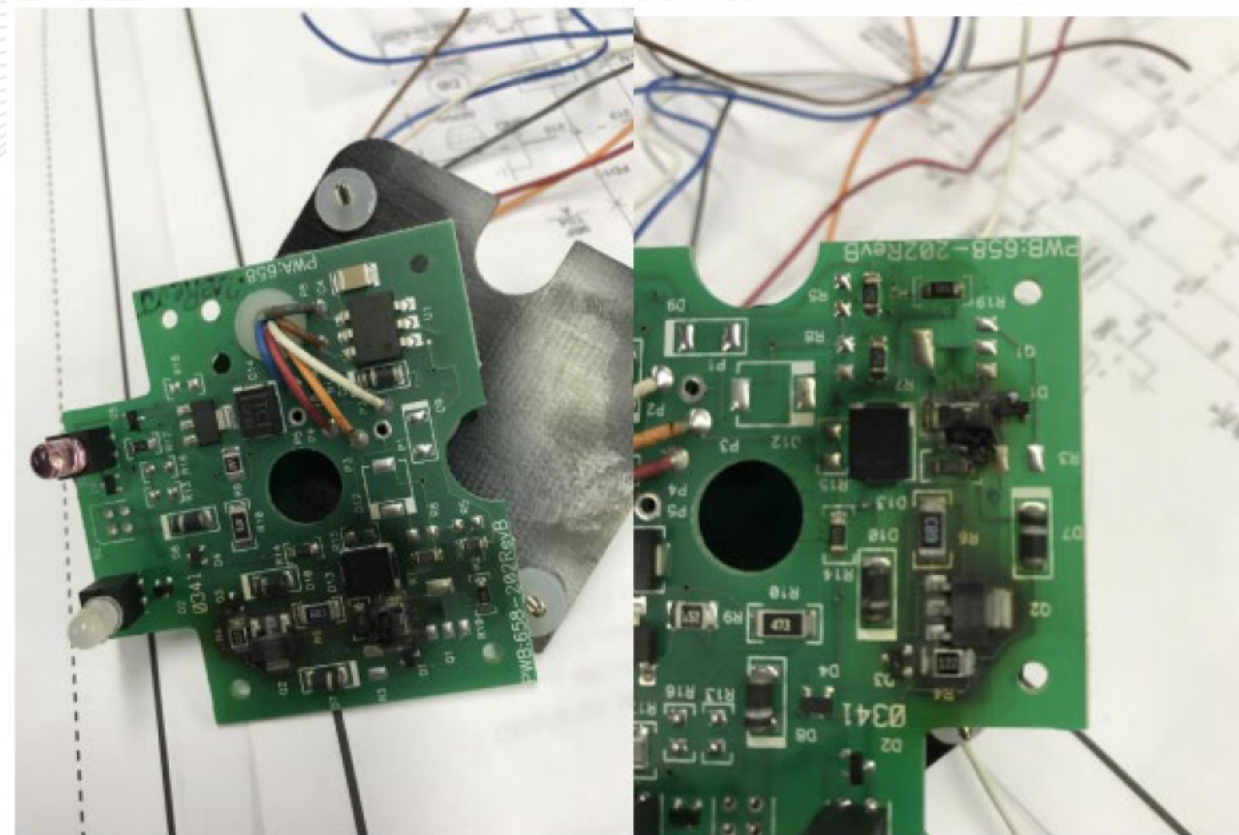
- A 2014 product advisory note was found detailing potential issues with the circuit board
- The entity had no record of receiving the notice
- The entity surveyed to determine the locations of the affected products
- Replacement of either the circuit board or the entire lockout relay was done

Figure 2: Diagram showing the faulty lighted nameplate control circuit board [1]

- Reach out to manufacturer for more information when needed from a product advisory to determine system risk and required corrective actions
- Develop procedures to log and review future advisory notes
- Survey manufacturers to ensure that all advisories are received, logged, and reviewed
