Sub Regional RTEP Committee: Western AEP Supplemental Projects

July 16, 2021

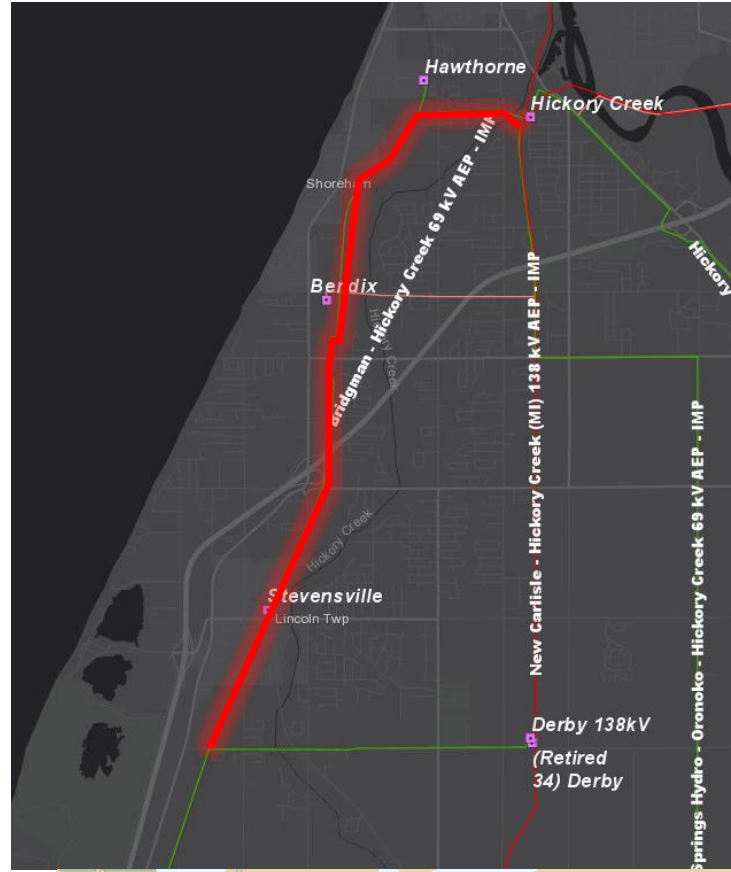
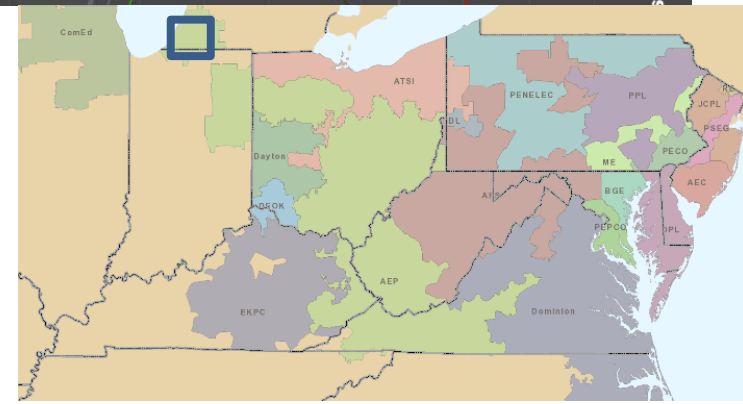
Derby – Hickory Creek 69kV line:

- ~6.2 miles of 1965 336.4 ACSR wood line exist on this line.
- Structures fail NESC Grade B, AEP Strength requirements, and ASCE structural strength standards
- Since 2015 there have been 13 momentary outages and 1 permanent outage on this circuit
- 13 structures were inspected by drone with 10 assessed by ground crew
 - 8 have flashed insulators
 - 7 had wood decay
 - 54% of poles inspected by ground crew had beyond normal decay.
- 24 structures have open conditions on this line including burnt insulators, broken/rust guys and corroded shield wires

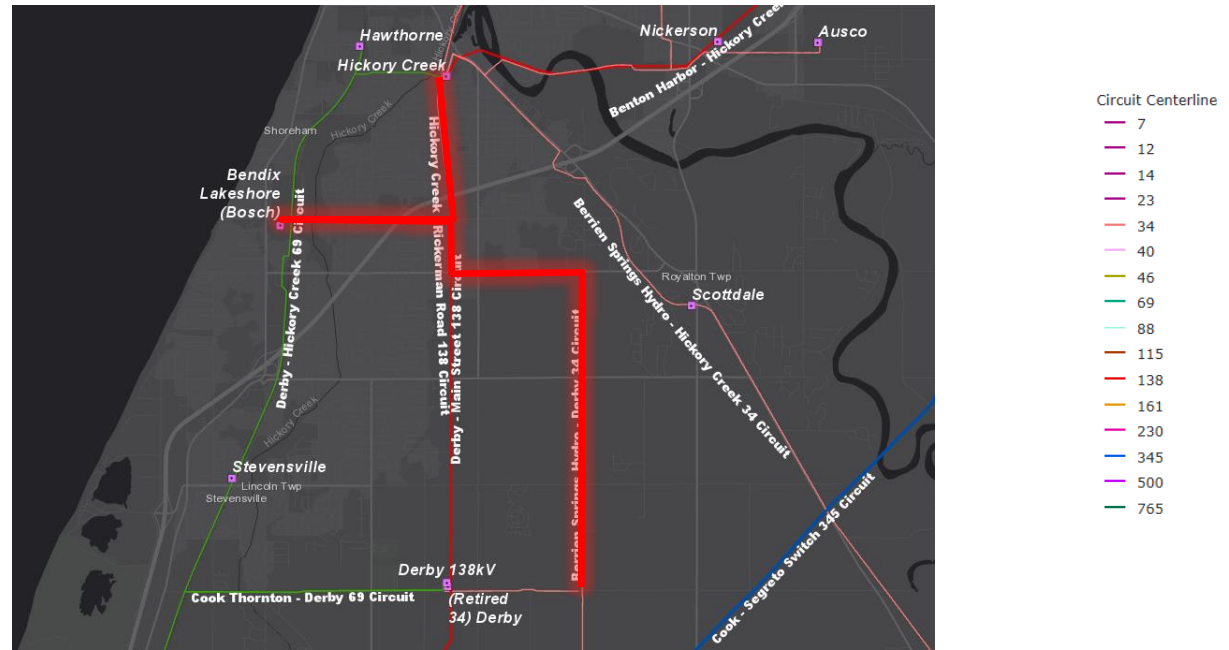
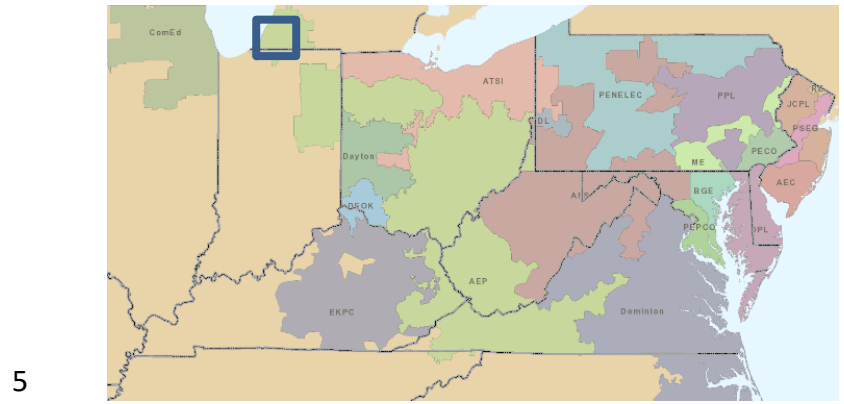
- Derby – Hickory Creek 34.5kV line (6.16 miles):**
- Majority structures are 1957 wood pole crossarm style.
 - Conductor is original 1957 4/0 Copper conductor
 - Insulation is legacy cap and pin style insulation
 - Structures fail NESC Grade B, AEP Strength requirements, ASCE structural strength standards, Insulation standards minimum leakage distance and shielding angle.
 - 24 were assessed by drone with 18 assessed by ground crew.
 - 50% of crossarms had ground or shell decay
 - 15/24 drone inspected poles had moderate decay or splitting arms
 - Most insulators and attachment hardware was corroded
 - Currently there are 82 structures with open conditions on this segment including rot, corrosion, splitting, twisting and bowing on the poles and corssarms.

- Bendix Lakeshore 34.5kV Tap (1.73 miles):**
- Majority structures are 1952 wood pole crossarm style.
 - Conductor is original 1952 4/0 ACSR
 - Structures fail NESC Grade B, AEP Strength requirements, ASCE structural strength standards, Insulation standards minimum leakage distance and shielding angle.
 - All structures were assessed by drone with 10 assessed by ground crew.
 - 25% of crossarms had decay
 - All structures had moderate levels of decay
 - Several crossarms had insect damage
 - Currently there are 11 structures with open conditions on this segment including rot, cracked wood, and woodpecker damage.
 - Line is a radial line which is difficult to maintain due to outage constraints.

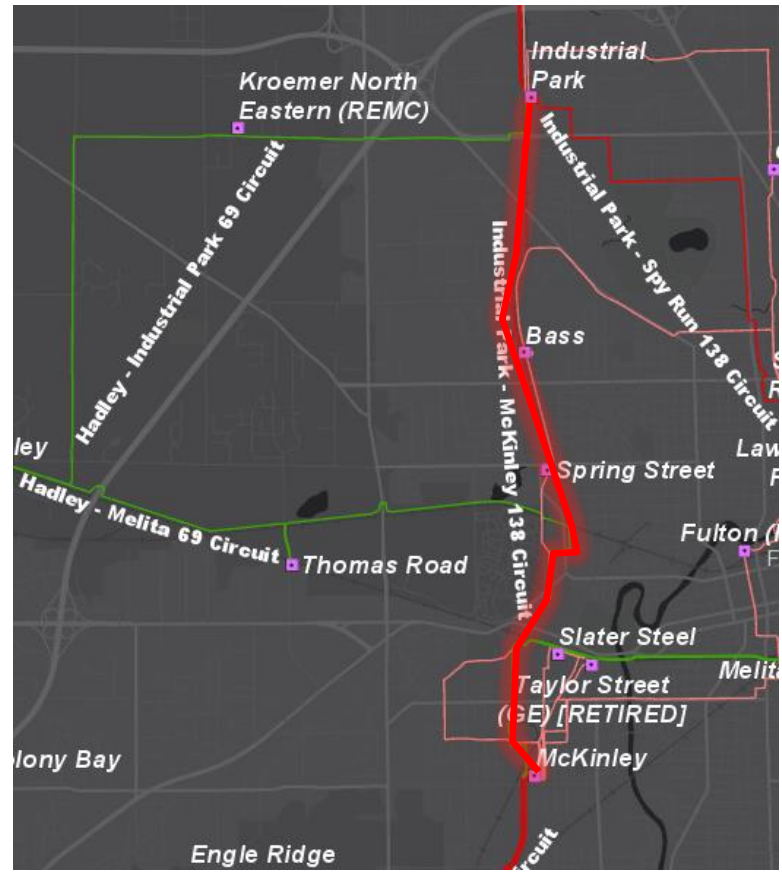
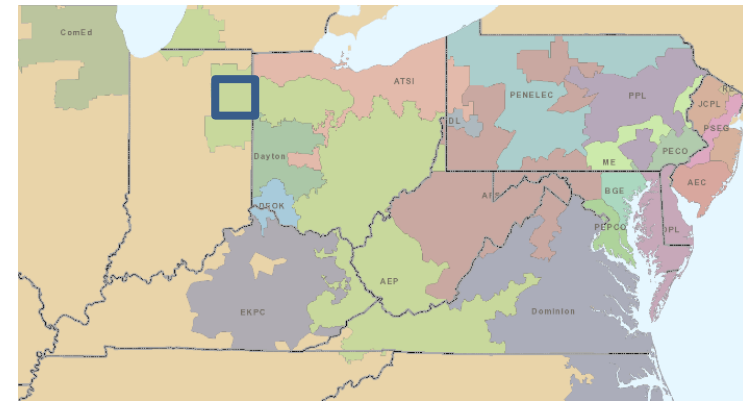
- Structures fail NESC Grade B, AEP Strength requirements, and ASCE structural strength standards
 - 18 structures were inspected by drone with 11 assessed by ground crew

- 9 structures found to have moderate-heavy checking or insect/bird damage
 - Several instances of insulators tipping away from pole
 - 81% of poles inspected by ground crew had beyond normal decay.

- 12 open conditions are on this line including woodpecker damage, damaged guy wires, damaged insulators

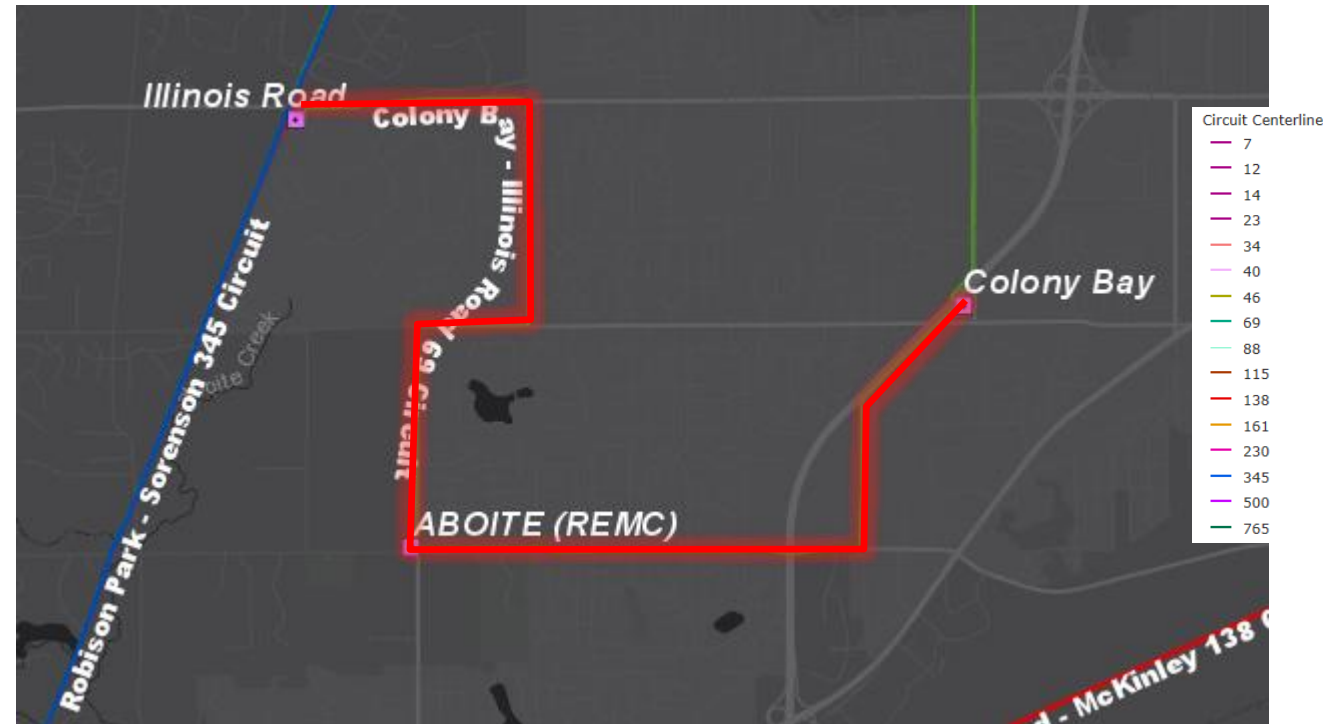
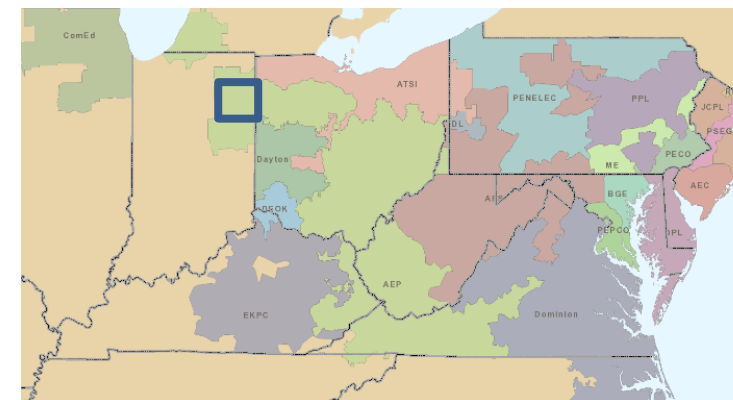
- 71 of the 189 poles are original 1969 wood poles.
- 6.33 miles of line is original 1969 556.5 AL conductor
- Since 2015 there have been 6 momentary outages
- Structures fail NESC Grade B, AEP Strength requirements and ASCE structural strength standards
- 14 of 36 structures assessed had issues such as ground line decay, insect/bird, shell damage
- 30% of structures on this line were identified as having beyond normal levels of decay.

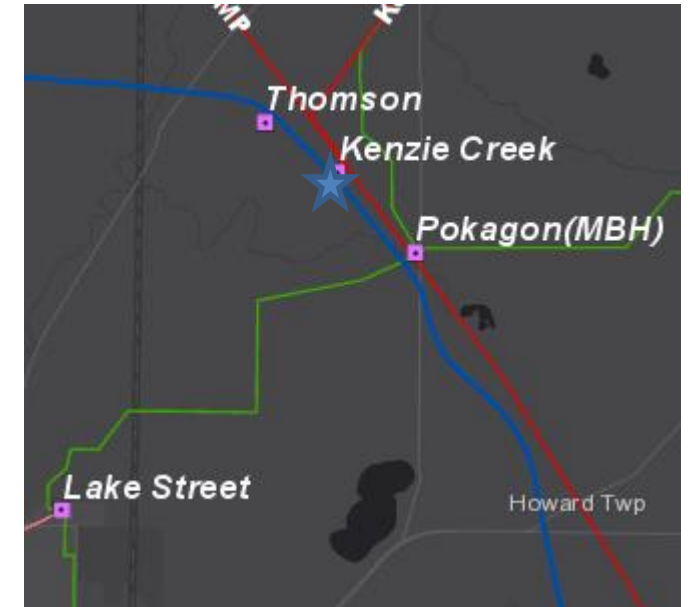
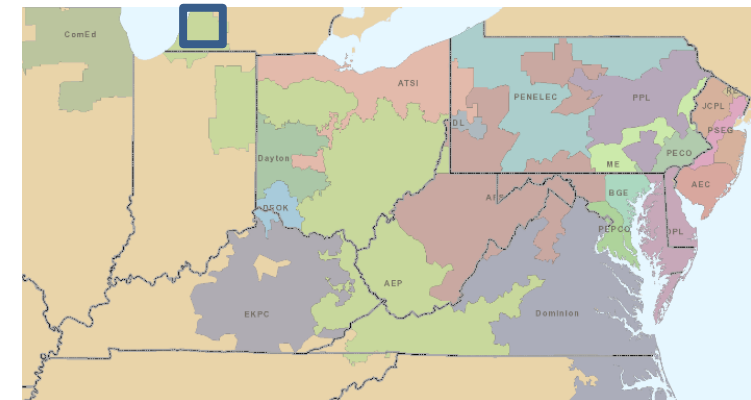
- **Kenzie Creek 345/138/69kV**
- CB “F”, “F1”, “F2”, “G” and “G1” are 1990’s vintage 145-PA type breakers
 - The 145-PA Type Breakers are experiencing marked increases in malfunctions. There have been 437 recorded malfunctions on 132 total units of this model type on the AEP System. The most common issues are related to loss of SF6 gas and mis-operations. The expected life of the bushing gaskets and door inspection port seals is 25 years. Seals that are no longer adequate can cause SF6 leaks to become more frequent. Low SF6 pressure in the breaker reduces the ability of the breaker to correctly interrupt a fault. Additionally, low pressure alarms and SF6 leaks lead to increased maintenance costs. The manufacturer provides no support or parts for this model of circuit breakers. Finally, SF6 leaks impact the environment.

- The CB’s have experience the following faults and are above the manufacturers recommended rating of 10
 - Breaker G: 39
 - Breaker G1: 24
 - Breaker F1: 12

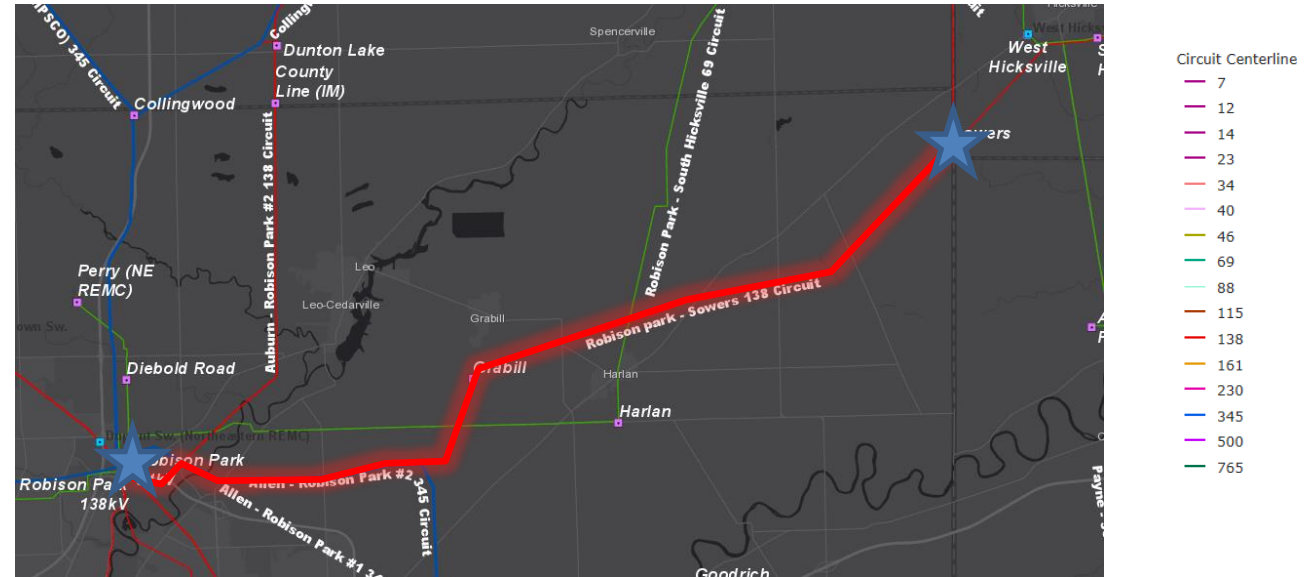
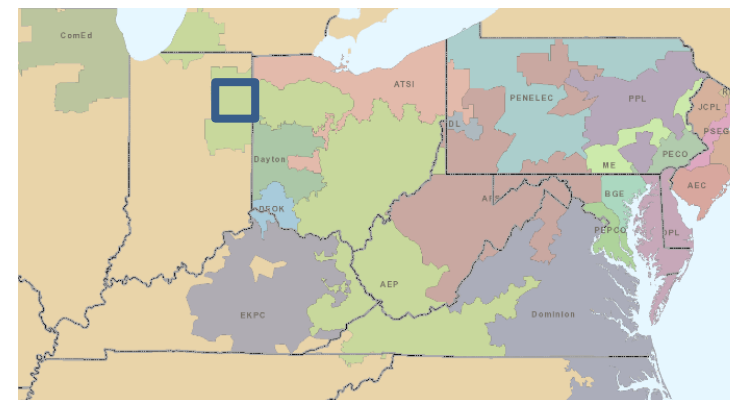
- 13.6 miles of this 18 mile line is 1966 wood H Frame construction
- 4.3 miles of this 18 mile line is 1966 Steel lattice and isn't identified as a need at this time.
- 17.9 miles of this 18 mile line is 1966 636 Grosbeak ACSR conductor
- Structures fail AEP Strength requirements and ASCE structural strength standards and AEP Shielding requirements
- The 2015-2020 time period has seen 4 momentary and 3 permanent outages
- Line has been subject to 464,404 CMI to customers served out of Grabill station.
- 15 structures were inspected by drone with 16 assessed by ground crew
 - Moderate shell decay on most wood poles
 - Most Cross Arms have moderate decay on top side of arms
 - 40% of structures had broken/missing grounds.
- 11 structures with open conditions are on this line currently including disconnected X Braces/Crossarms, Rot Top and broken ground leads.

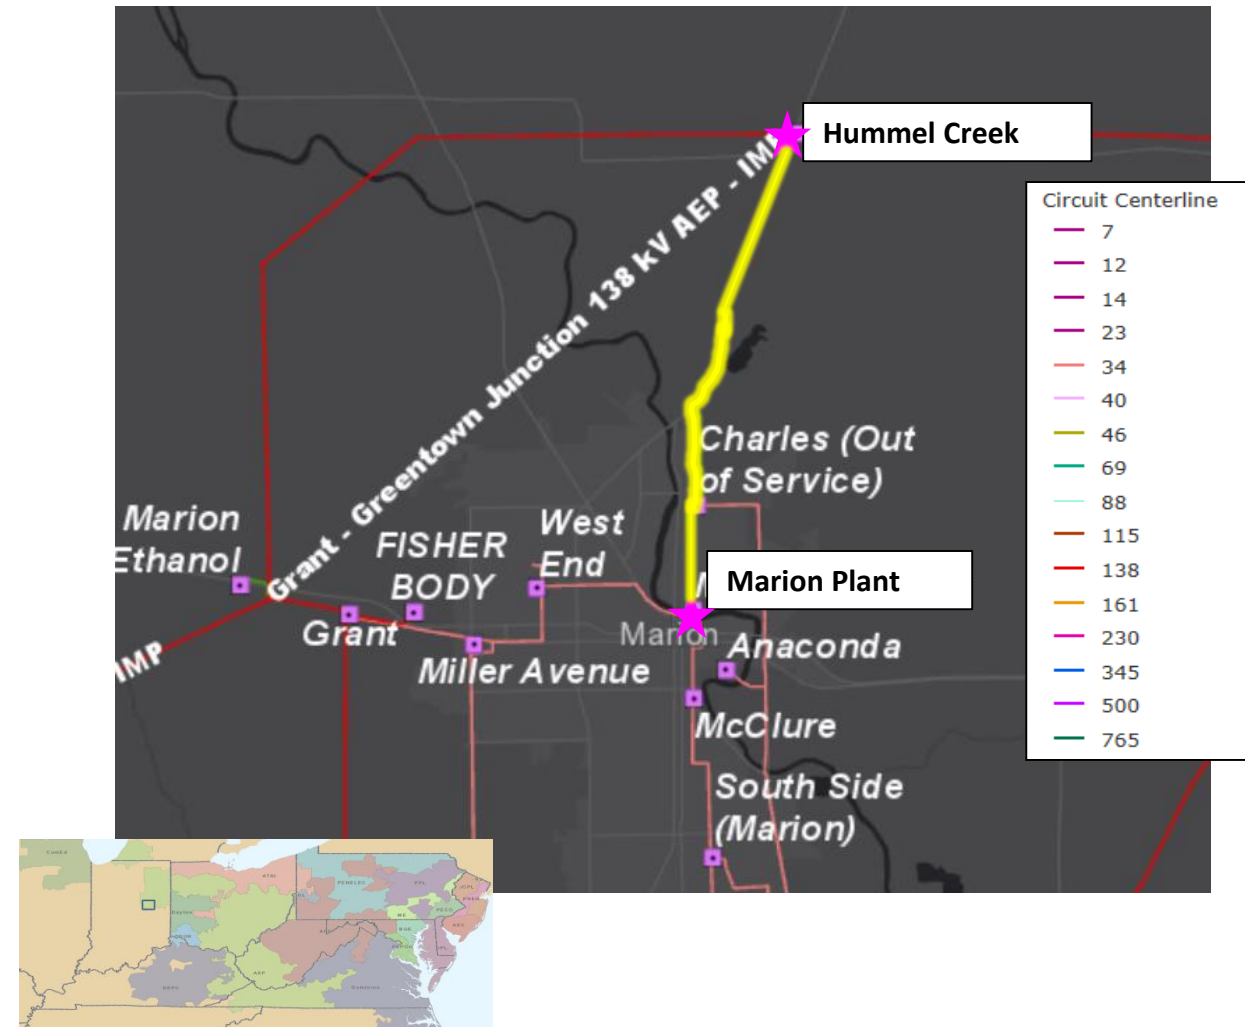
- Porcelain insulators
- Conductor Type: 556,500 CM ALUM/1350 19 Dahlia
- Condition Summary
 - Number of open conditions: 19 structure open conditions
 - Open conditions include knee/vee brace, shielding/grounding open conditions related to the ground lead wire with missing or stolen, hardware, broken insulators.

- Based on the ground crew assessment most poles and arms assessed are in poor condition with a overall condition of the line moving towards increased maintenance cycles and less reliability.

- Structures fail NESC Grade B, AEP Strength requirements, and ASCE structural strength standards
 - The grounding method utilizes butt wraps on every other structure, providing reduced lightning protection for the line.

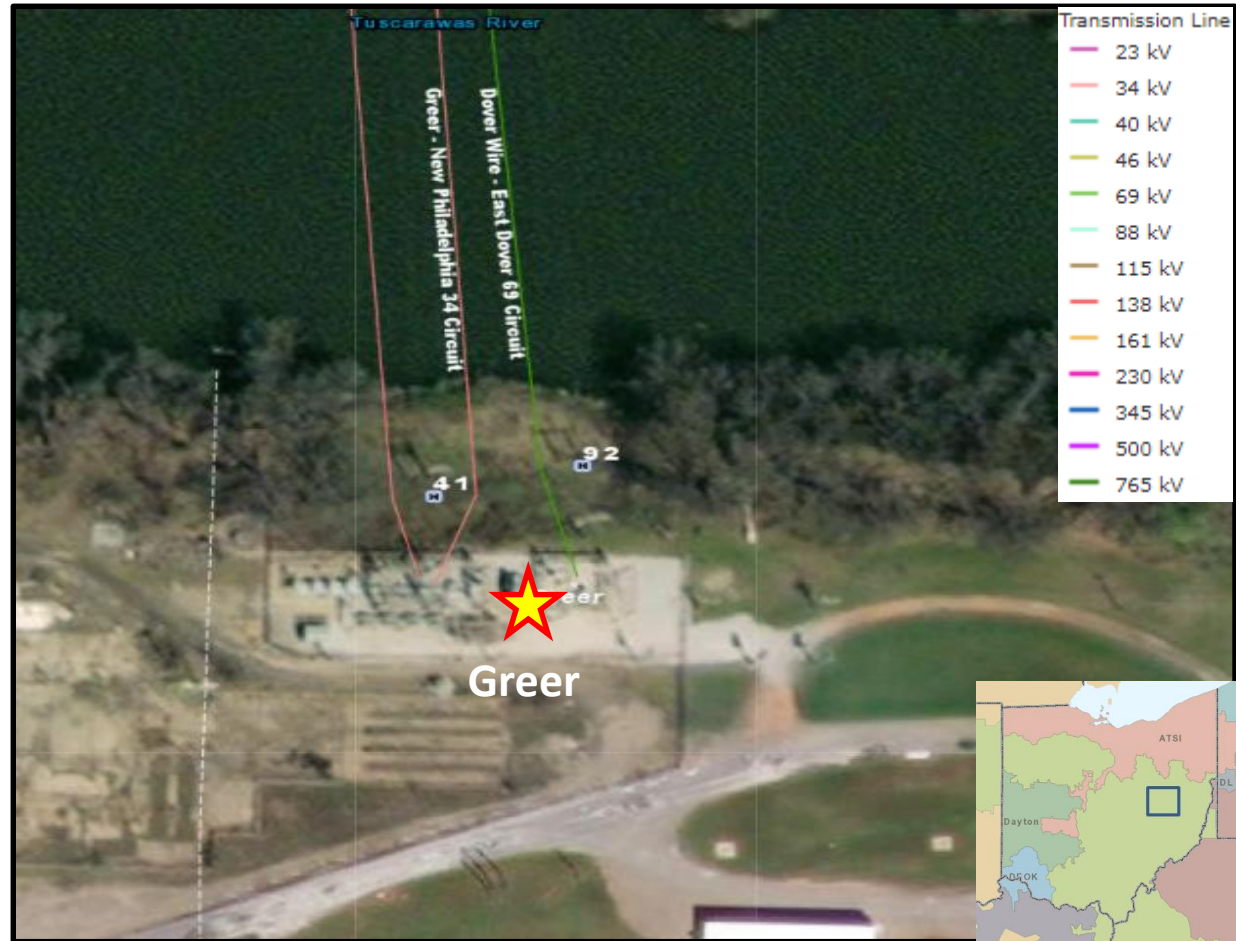
- Transformer Age: 1958
- This unit had oil processing done in 2009 but there have been subsequent increases in combustibles in the DGA that indicate continued breakdown of insulating and internal components. The CO/CO2 ratio is above the warning threshold and this unit has experienced overheating which has deteriorated the insulation.

Relays: Currently, 28 of the 31 relays are of the electromechanical type, which have significant limitations with regards to fault data collection and retention. There is minimal room in the existing control house for replacement

Other: The station yard and control building are overall in very poor condition, with peeling paint, heavy rusting, possible asbestos and PCB's, and obsolete cap-and-pin insulators. The transformer foundations are crumbling, with signs of past oil leaks.

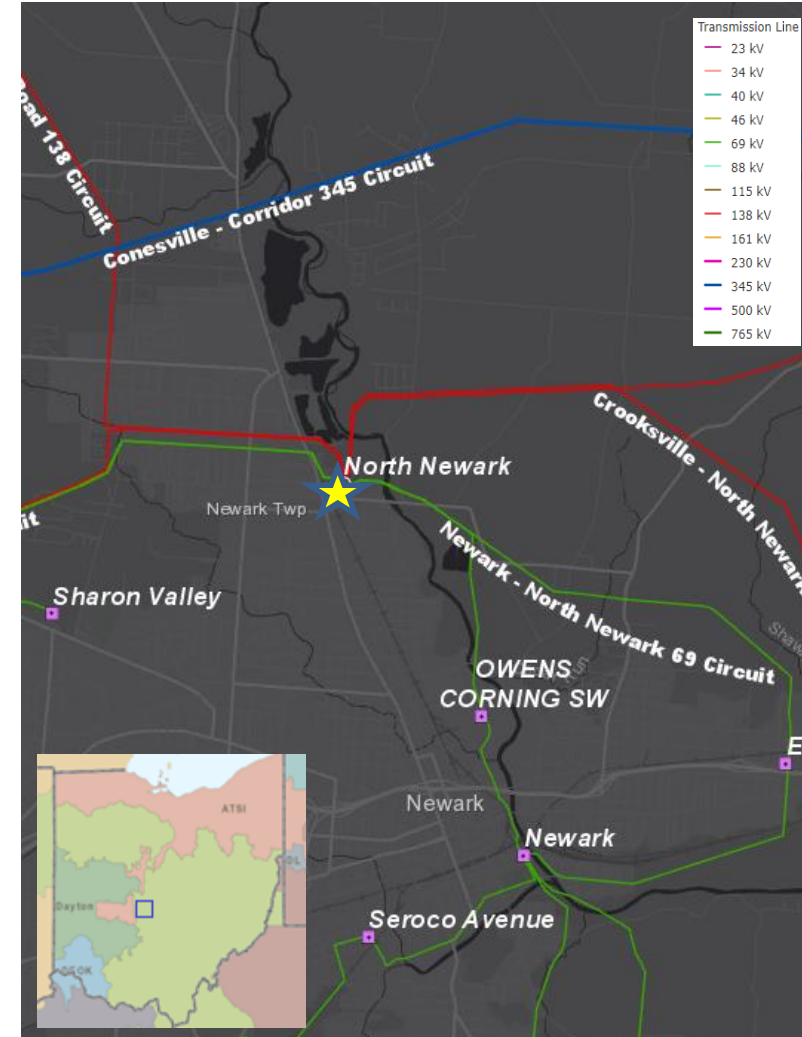
- Breaker Age: 1952: H & 1947: P
- Interrupting Medium: (Oil)
- Fault Ops: H: 46 & P: 38 (Manufactured recommended number of fault ops is 10)
- Additional Info: These breakers are FK type oil filled breakers without oil containment; Oil filled breakers have much more maintenance required due to oil handling that their modern, SF6 counterparts do not require.

- CB-H recently failed to stay closed after being tripped, and is currently being operated normally open. As a result of being N.O., we are leaving customers on the 138 kV circuit to Crooksville served radially.

- Recent testing of CB-P revealed poor bushing health along with alignment issues, bad contacts, bad closing resistors, and the connections make and break multiple times during an operation. These issues are causing excessive arcing and burning on the contacts.

- Field personnel are treating these breakers as a failure situation and are looking to replace them as soon as possible.

- Switcher Age: 1989
- Interrupting Medium: (SF6)
- Additional Info: This switcher is a S&C Electric, Mark V type that has no gas monitor and currently in-service units on the AEP system have experienced 110 malfunctions from May 2000 to August 2019. Failed operational components including high contact resistance, gas loss, and interrupter failure represent half of these malfunctions. Two malfunctions of note were catastrophic equipment failures involving failures to trip.

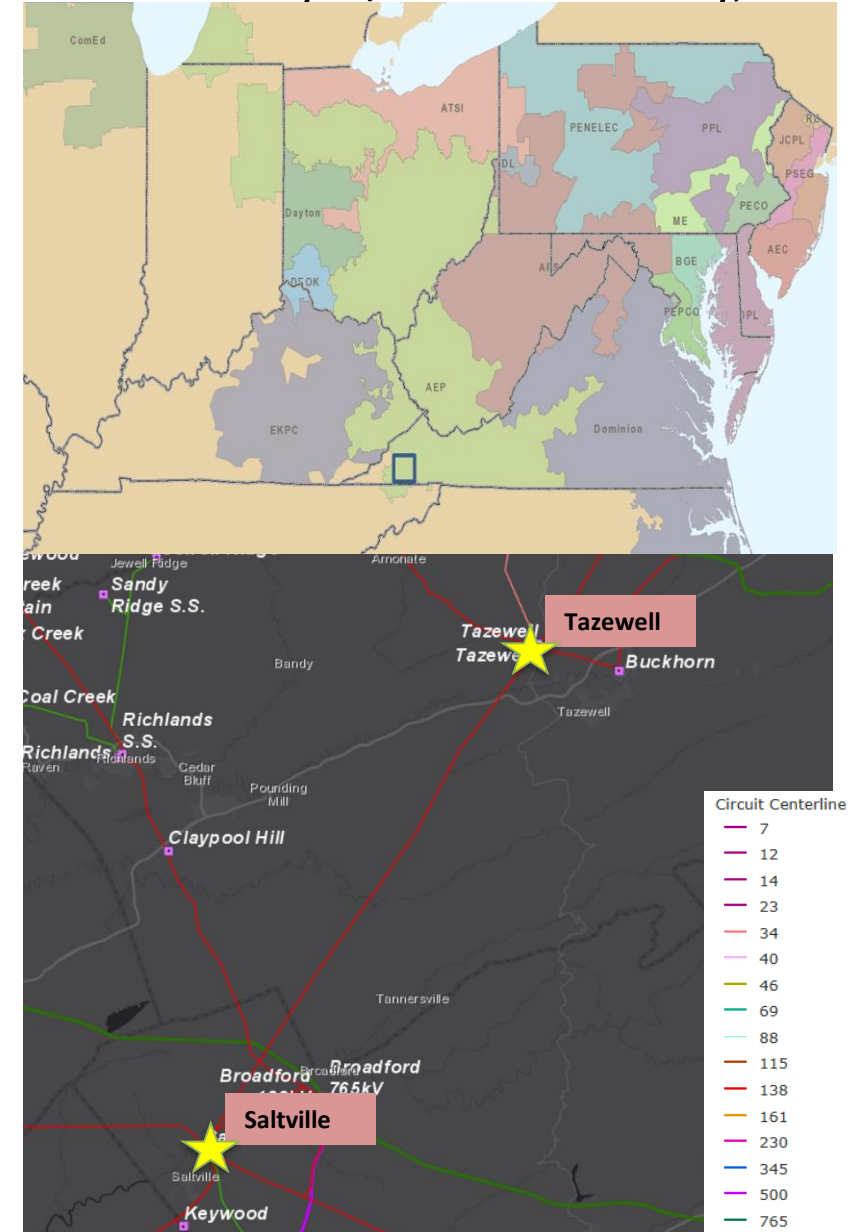
- Total structure count: 98
- Number of open conditions: 26
 - Open conditions include: broken conductor strands, broken/burnt insulators.
- Unique structure count with open conditions: 12 (12%)

- Additional Info on Insulator & Hardware Corrosion:
 - Section Loss: The connecting elements including the tower attachment hole and the insulator hook have experienced serious cross-section loss due to corrosion and wear. This loss of metal cross-section significantly reduces the capacity of the connection

- Corrosion: The insulator caps and connecting hardware have experienced heavy to complete loss of galvanizing. When the protective galvanized coating is gone or significantly compromised, the bare steel corrodes at an accelerated rate

- Tower members with corrosion and damage. Lattice tower structures have little structural redundancy. A failure of one member of the structure will impact the integrity of the structure and may cause the entire tower to collapse.
