NERC Lessons Learned

Battery Energy Storage System
Cascading Thermal Runway

Catastrophic Failure of 345kV Oil Filled Metering Current Transformer in a Transmission Substation

Controlled Islanding due to Wildfire
Event

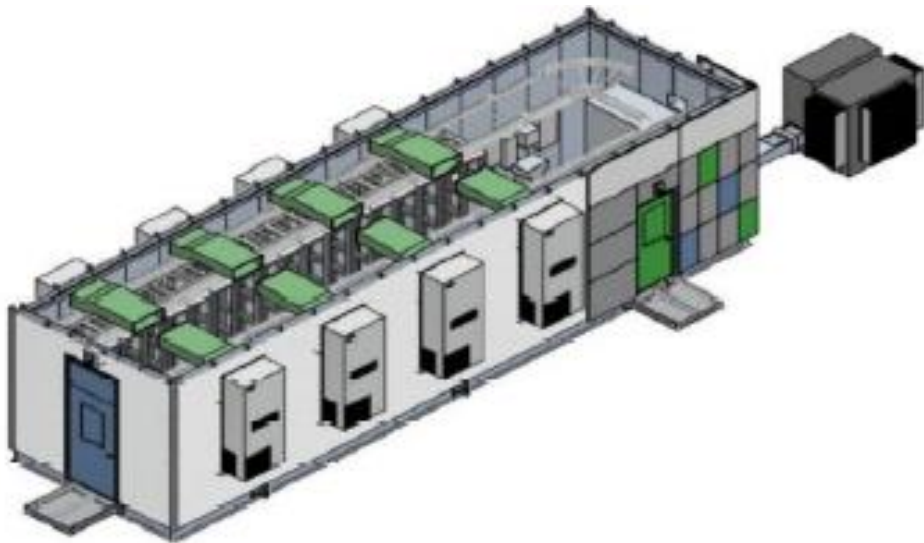
*Figure 1: General Layout of the BESS
(Image credit: APS) [1]*

- Remote alarm triggered at 16:55 PST by fire in a BESS
- Explosion at 20:04 PST injured firefighters and significantly damaged the BESS
- Cause of fire identified as a cascading thermal runaway event
- BESS was performing a solar smoothing function
- Battery cell in the BESS experienced sudden voltage drop during charging cycle
- The thermal runaway event activated the smoke detection system and cascaded into neighboring cells and their batteries

- Improve training, emergency response planning, and procedures for first responders, operations, and maintenance personnel
- Work with suppliers, industry experts, and standards bodies to:
 - Minimize or eliminate cell-to-cell and module-to-module heat transfer to stop thermal runaway
 - Implement fire detection and suppression system designs to fully manage a thermal runaway
 - Implement design changes incorporating monitoring and remote reporting of flammable gas concentrations and implement ventilation systems to mitigate

- Conduct hazard mitigation analysis
- Develop a pre-incident guide for future training of utility personnel and fire services
- Conduct training, familiarization tours and exercises with your local fire department

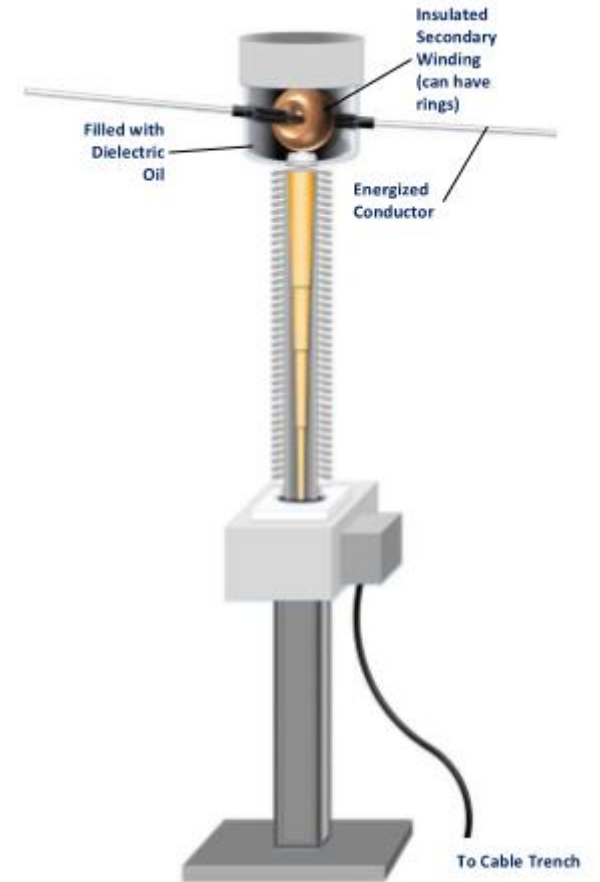
Figure 5: Wire Wound CT Simplified Cutaway [2]

- Catastrophic failure of 345 kV C-phase transformer caused the CT to explode causing fire and spread of glass shrapnel across switchyard
- Fault also led to tripping of 345 kV South Bus, removing Capacitor Bank #2 and inverter based controlled reactive device
- 345 kV Breaker scheduled maintenance led to open-ended Line B
- Entity conducted a root cause analysis

- Plan was devised to replace all similar CTs
- Entity re-evaluated its maintenance and testing program
- Oil-filled electromagnetic CTs should be evaluated for removal/replacement
- Formalize industry-wide equipment lesson sharing
- Obtain better understanding of failure modes and mechanisms
- Entities should evaluate inspection, maintenance, testing steps and associated frequencies for similar oil-filled equipment
- Use polymer instead of ceramic insulators
- Consider replacement with optical CT
