Sub Regional RTEP Committee: Western AEP Supplemental Projects

July 16, 2021

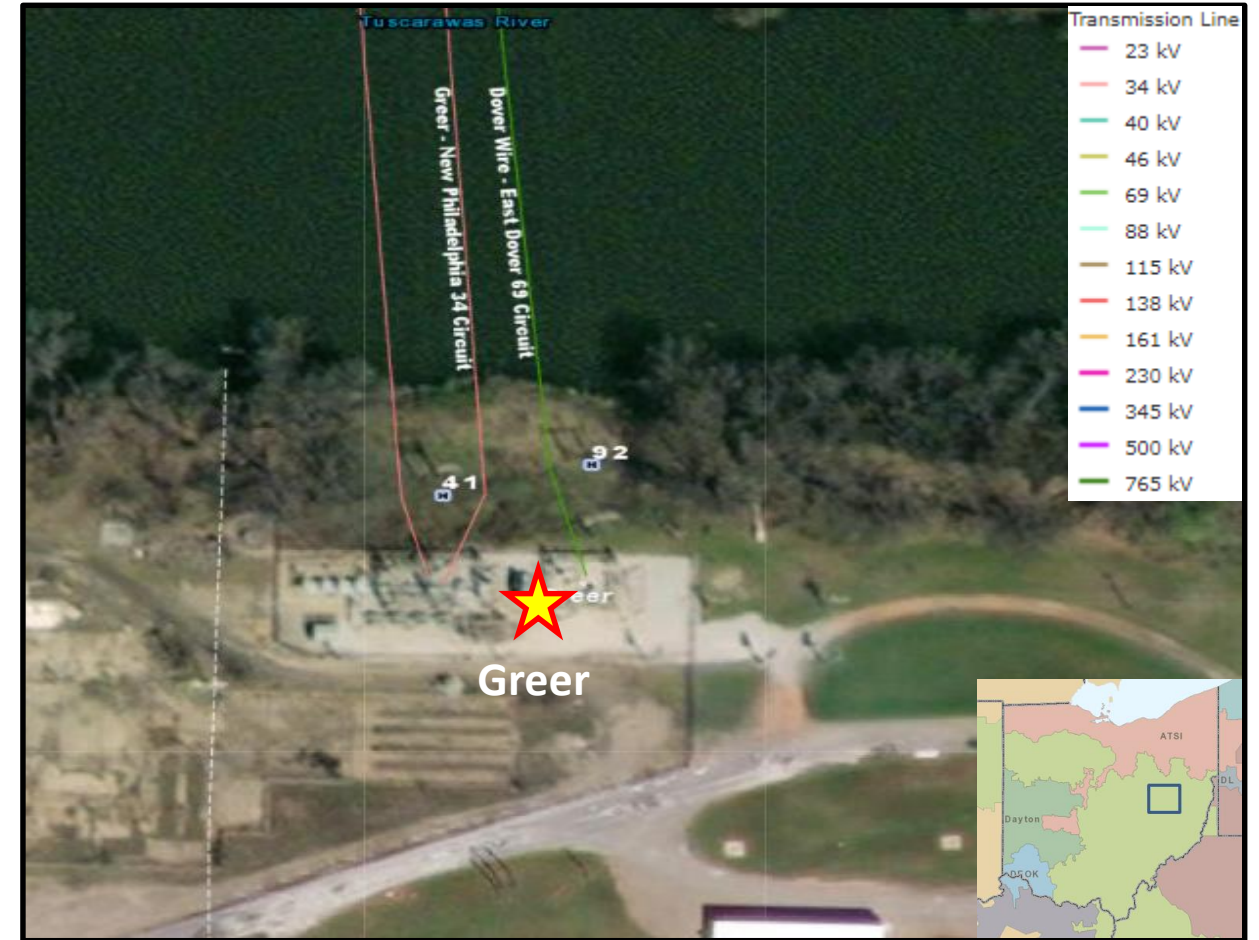
Greer station is a 69-34.5kV-7.2kV delta station serving an industrial customer, along with providing a source to the local 34.5kV sub-transmission system. The station is connected via a hard tap to the Dover Wire-East Dover-Greer 69kV circuit, which is a 3-terminal line. Three-terminal lines are more difficult to reliably protect and more prone to overtripping. The hard tap connection makes it more difficult to perform 69kV maintenance in the area, due to the lack of line sectionalizing switches at the tap point.

The 69-34.5kV transformer lacks a high-side fault-interrupting device, and only has a motor-operated switch & ground-switch system, which requires remote-end 69kV fault clearing.

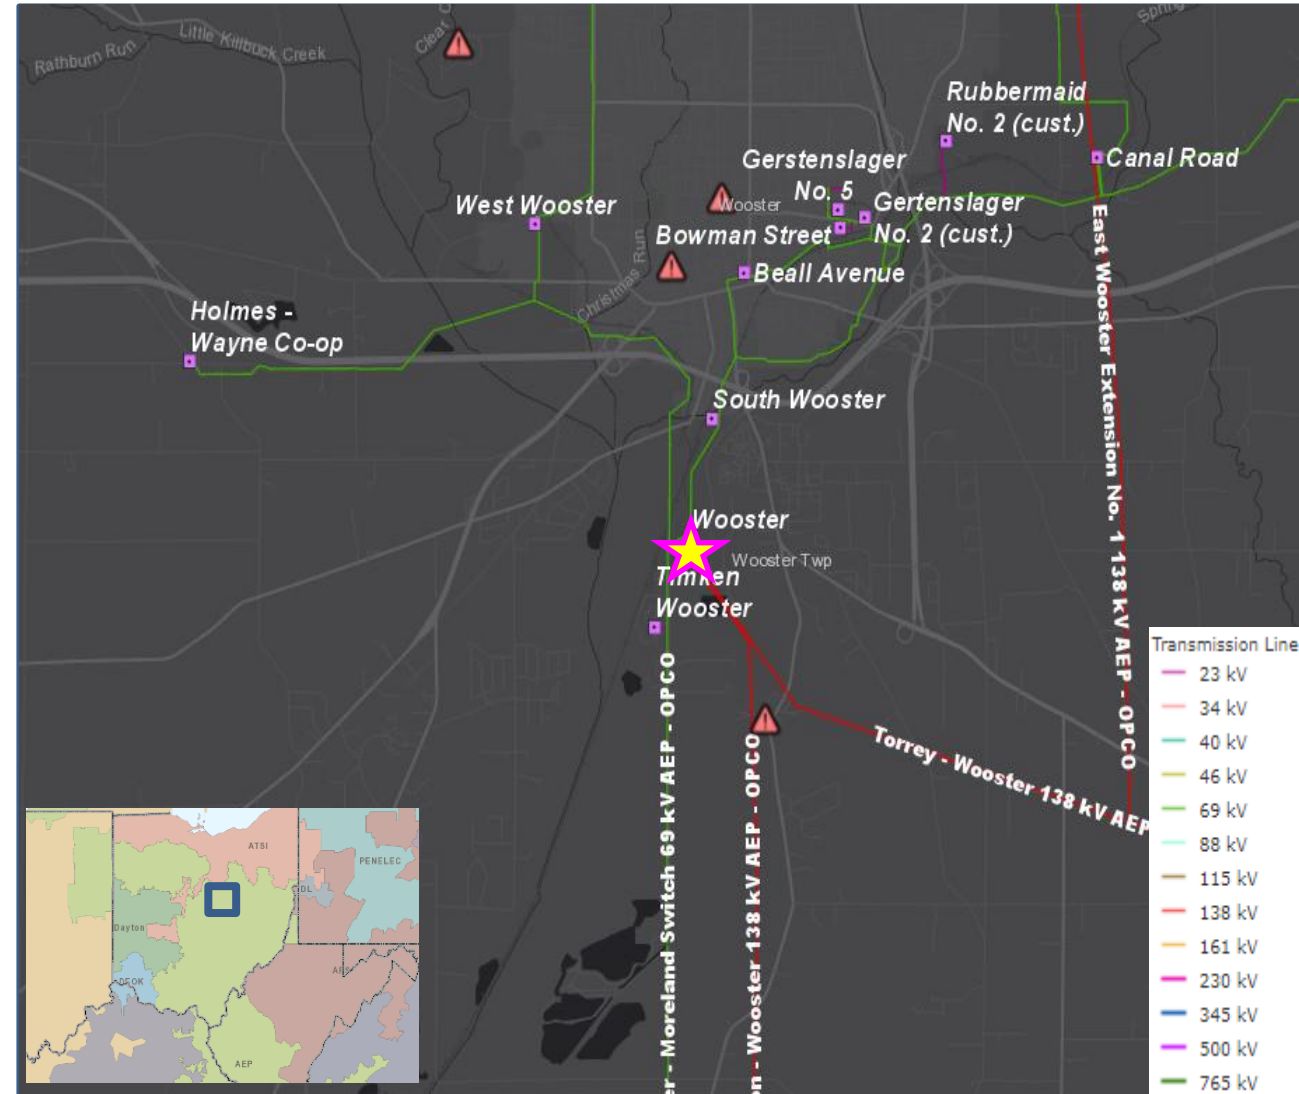
Circuit Breaker: CB-G

- Manufacture Date : 1986
- Interrupting Medium: SF6 Mark-V
- Additional: Mark V family of circuit switchers have no gas monitoring and these have experienced numerous malfunctions (110 over a 10 year period) across the AEP system. Failed components, gas loss, and interrupter failure represent half of these malfunctions. Two malfunctions of note were catastrophic equipment failures. Parts are expensive, especially because interrupters can only be replaced, not repaired, as they are hermetically sealed.

- Manufacture Date : 1968
- Interrupting Medium: Oil
- Fault Operations: 16
- Additional: These breakers are oil filled without oil containment; oil filled breakers have much more maintenance required due to oil handling that their modern, SF6 counterparts do not require

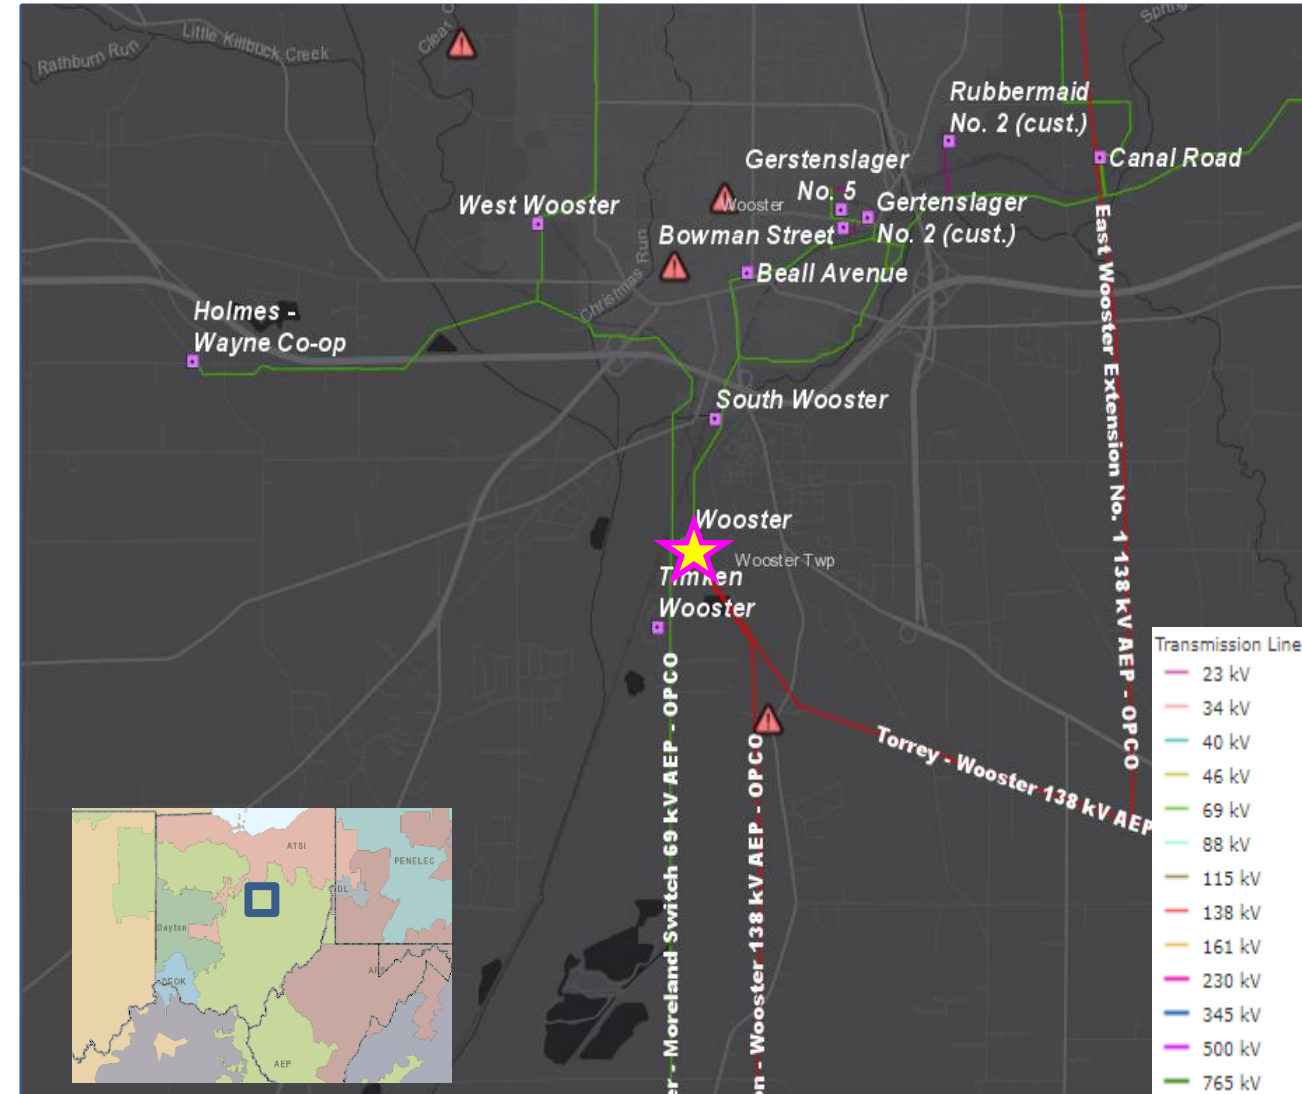
Transformer: Ground Bank-1

- Manufacture Date: 1953
- Additional: No arrestors are on this unit. Bushings and cooling fans are obsolete with no spare parts available. One oil pump is not functional. No oil containment. Dielectric and short circuit breakdown and moisture content has been detected in the oil.

- Manufacture Date : 1953
- Additional: Cooling fans are obsolete with no spare parts available. No oil containment. Dielectric and short circuit breakdown are indicated in the DGA.

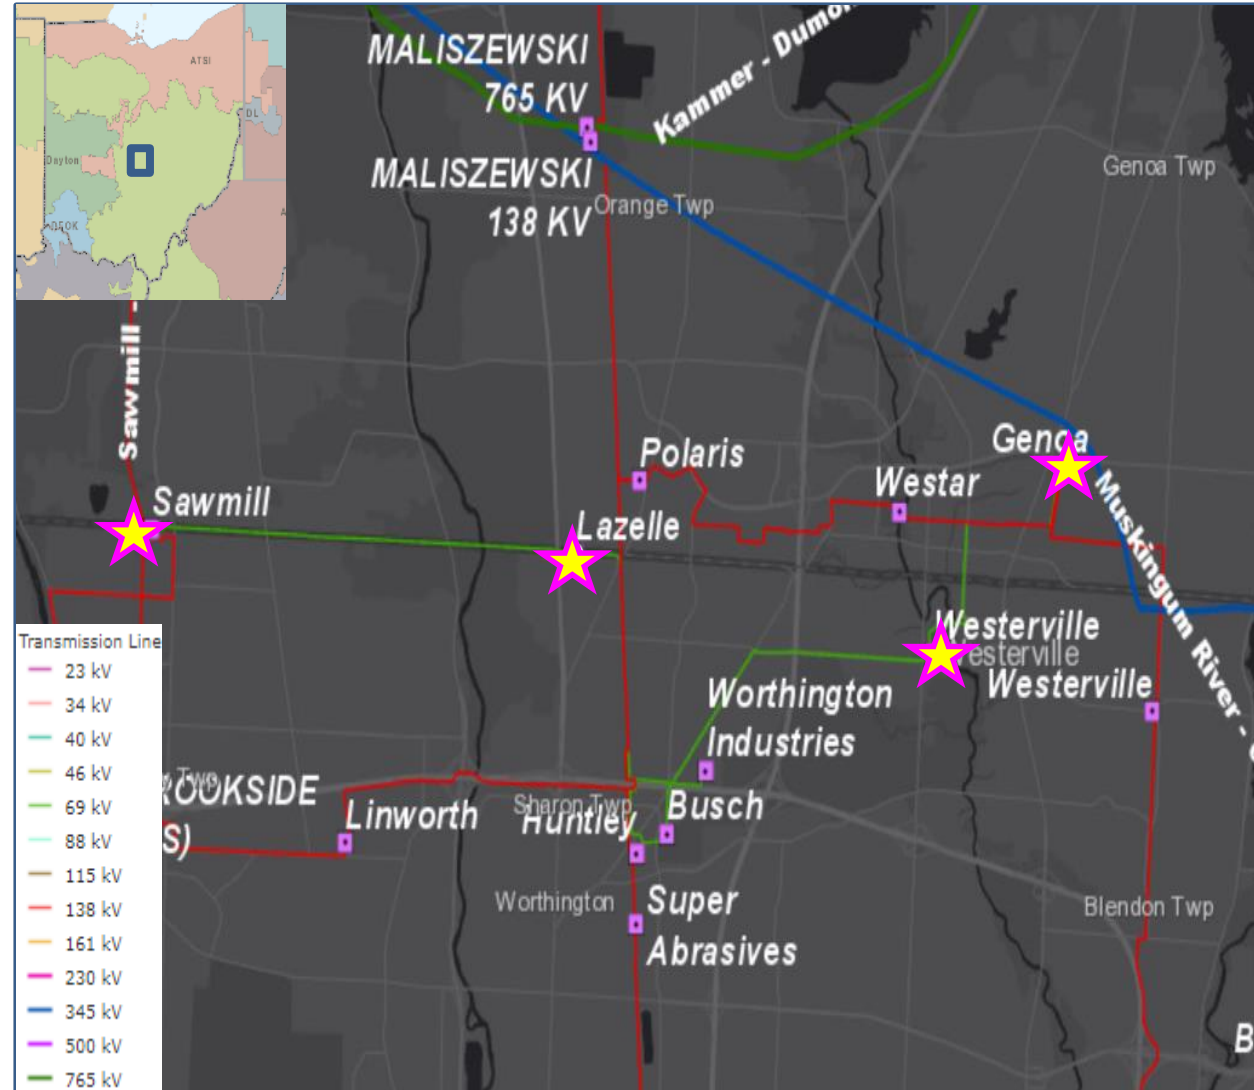
69 kV Circuit Breakers 62 & 63

- Breaker Age: 1967
- Interrupting Medium: Oil
- Fault Operations: 11 (CB-61)
- Manufacturer recommended Number of Operations: 10
- The manufacturer provides no support for these units and spare parts are increasingly more difficult to obtain. Signs of internal flashovers are present and heavy rust is showing on the breaker itself.
- Oil breaker maintenance has become more difficult due to the oil handling required to maintain them. Oil spills are frequent with breaker failures and routine maintenance and can become an environmental hazard.

- Breaker Age: 1967
- Interrupting Medium: Oil
- Fault Operations: 22 (CB-63)
- The manufacturer provides no support for these units and spare parts are increasingly more difficult to obtain. Signs of internal flashovers are present and heavy rust is showing on the breaker itself.
- Oil breaker maintenance has become more difficult due to the oil handling required to maintain them. Oil spills are frequent with breaker failures and routine maintenance and can become an environmental hazard.

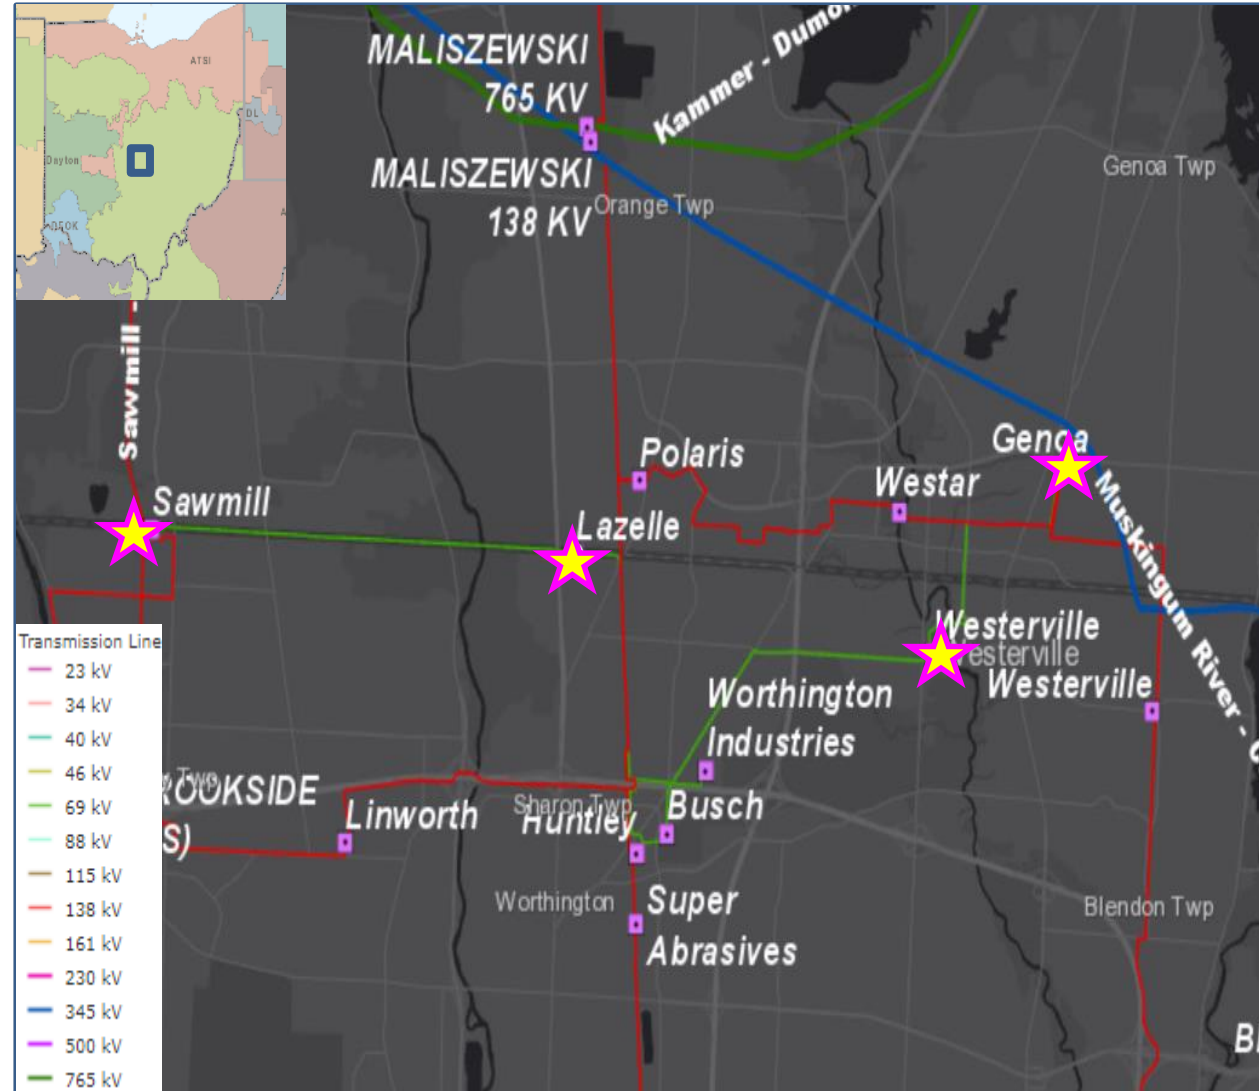
69 kV Circuit Breaker B

- Breaker Age: 1967
- Interrupting Medium: Oil
- Fault Operations: 15 (CB-64)
- Manufacturer recommended Number of Operations: 10
- The manufacturer provides no support for these units and spare parts are increasingly more difficult to obtain.
- Oil breaker maintenance has become more difficult due to the oil handling required to maintain them. Oil spills are frequent with breaker failures and routine maintenance and can become an environmental hazard.

- Breaker Age: 1989
- Interrupting Medium: Oil
- Oil breaker maintenance has become more difficult due to the oil handling required to maintain them. Oil spills are frequent with breaker failures and routine maintenance and can become an environmental hazard.
- The manufacturer provides no support for the family of circuit breakers and spare parts unavailable.
- This model family has experienced major malfunctions associated with their hydraulic mechanisms, eventually leading to failure.

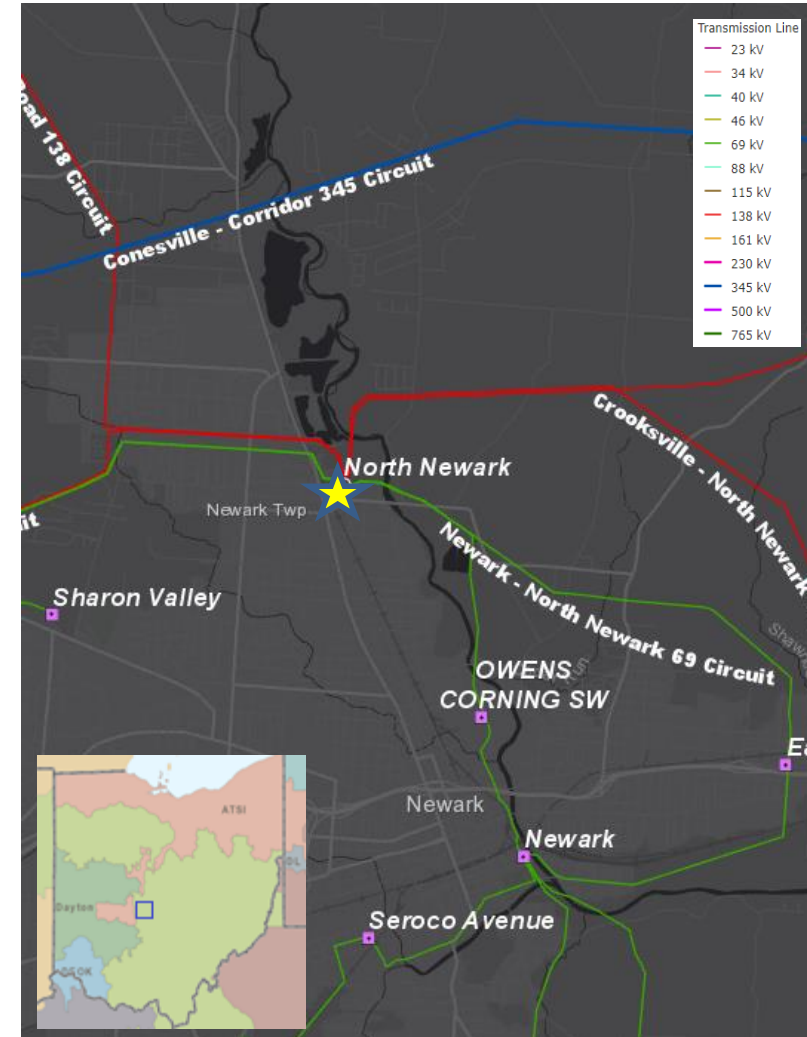
- Breaker Age: 1952: H & 1947: P
- Interrupting Medium: (Oil)
- Fault Ops: H: 46 & P: 38 (Manufactured recommended number of fault ops is 10)
- Additional Info: These breakers are FK type oil filled breakers without oil containment; Oil filled breakers have much more maintenance required due to oil handling that their modern, SF6 counterparts do not require.

- CB-H recently failed to stay closed after being tripped, and is currently being operated normally open. As a result of being N.O., we are leaving customers on the 138 kV circuit to Crooksville served radially.

- Recent testing of CB-P revealed poor bushing health along with alignment issues, bad contacts, bad closing resistors, and the connections make and break multiple times during an operation. These issues are causing excessive arcing and burning on the contacts.

- Field personnel are treating these breakers as a failure situation and are looking to replace them as soon as possible.

- Age: 1951: T1 & 1956: T2
- Historical data shows elevated volume of acetylene and methane that indicates arcing inside the transformer tank.
- Transformer tanks are leaking and have no oil containment.
- Additional Info.: Currently no sectionalizing on high side of Transformer 1 & 2, there are two dissimilar zones of protection (138 kV Bus, Transformer) .

Currently, 84 of the 115 relays (73% of all station relays) are in need of replacement. 73 of these are of the electromechanical type and 6 of these is of the static type which have significant limitations with regards to spare part availability and fault data collection and retention. In addition, these relays lack of vendor support. There are also 5 microprocessor based relays commissioned between 2006-2007 that may have firmware that is unsupported.

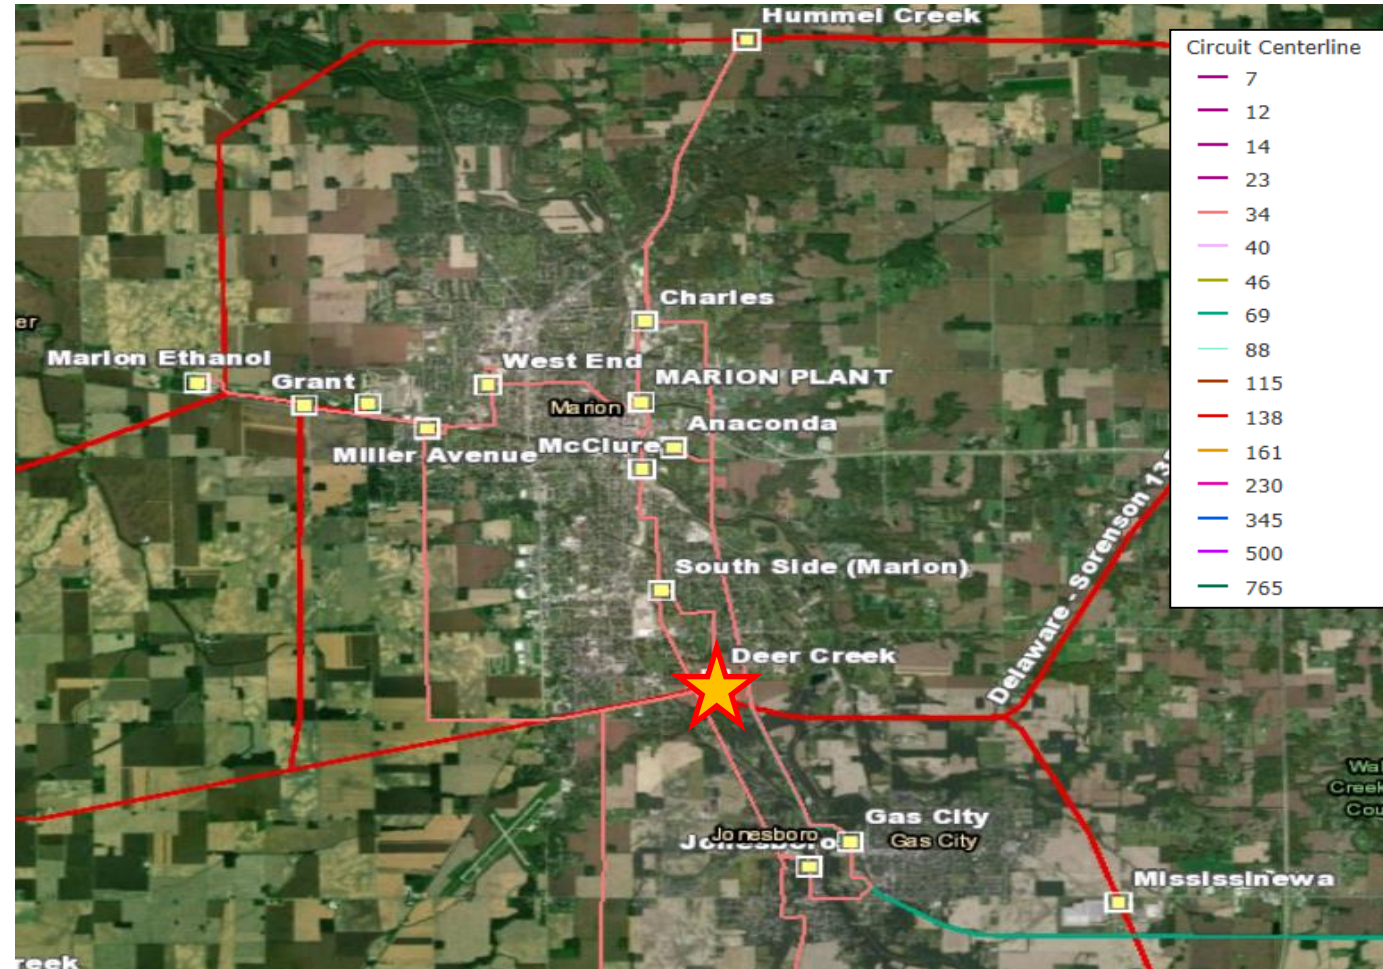
Deer Creek 34.5kV

- Breakers “K”, “F”, “M”, “H”, “V”, “W”
 - 1949-62 vintage FK oil breakers without containment
 - Fault Operations: CB K(9) CB F(1) CB M(17) CB H(16) CB V(5) CB W(1) - Recommended(10)
 - CB W is over the recommended amount of switching operations.

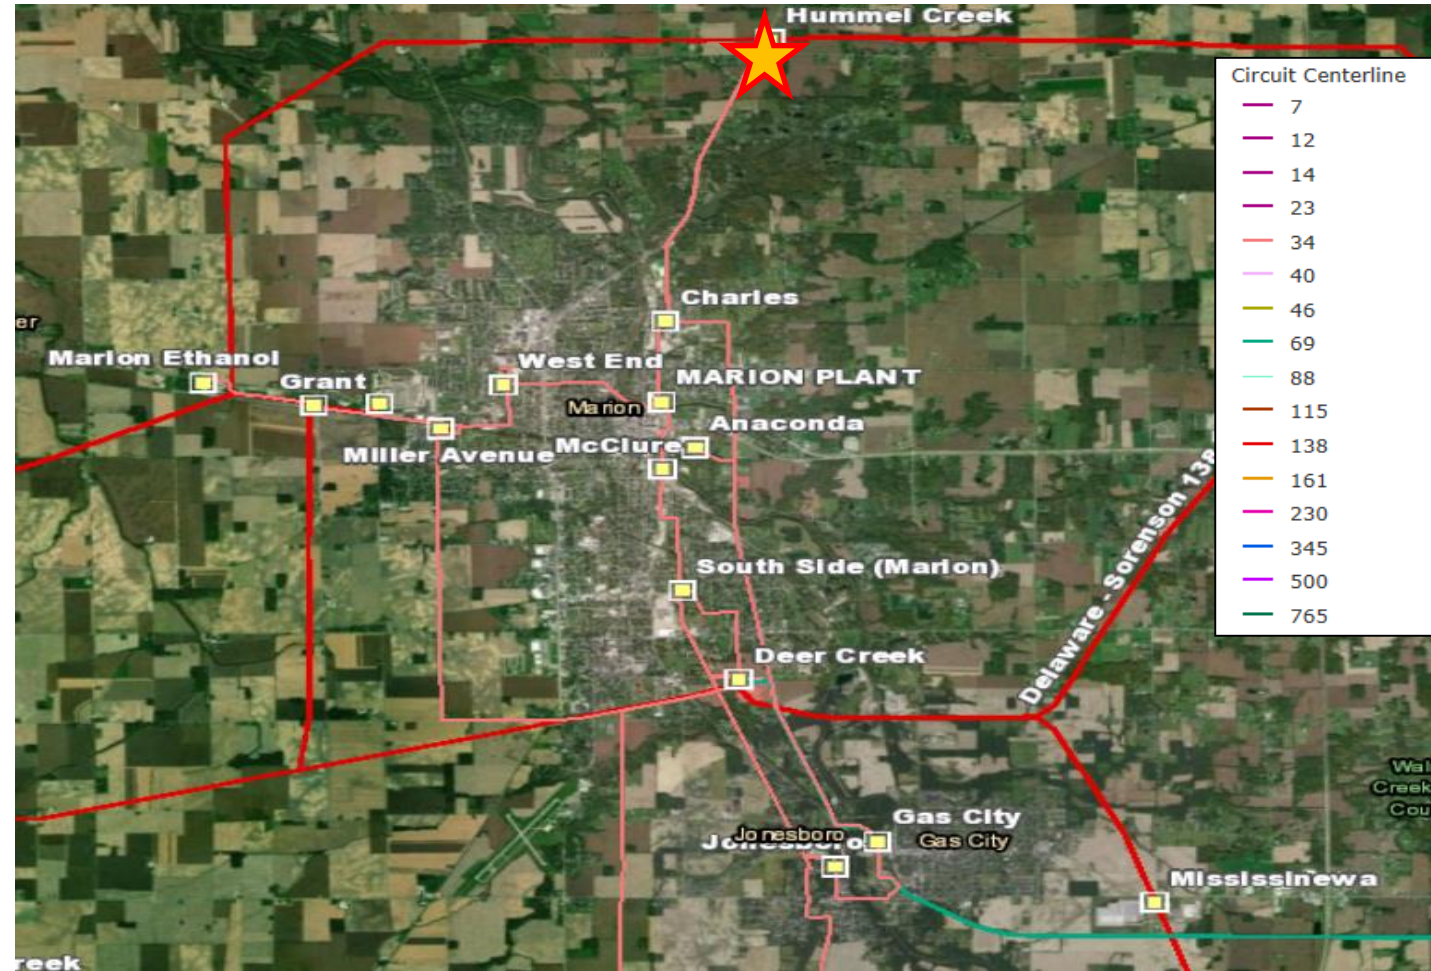
Hummel Creek 34.5kV

- Breakers “L” and “M”
 - 1949-1950 vintage FK oil breaker without containment
 - Fault Operations: CB M(33)– Recommended(10)

Hummel Creek 34.5 kV Station: Remove the 34.5 kV circuit breaker “M”. Replace 34.5 kV circuit breaker “L” with a system spare circuit breaker. Rebuild the 34.5 kV bus to a 69 kV standards. Install a 138 kV high side circuit switcher on the 138/34.5 kV transformer.

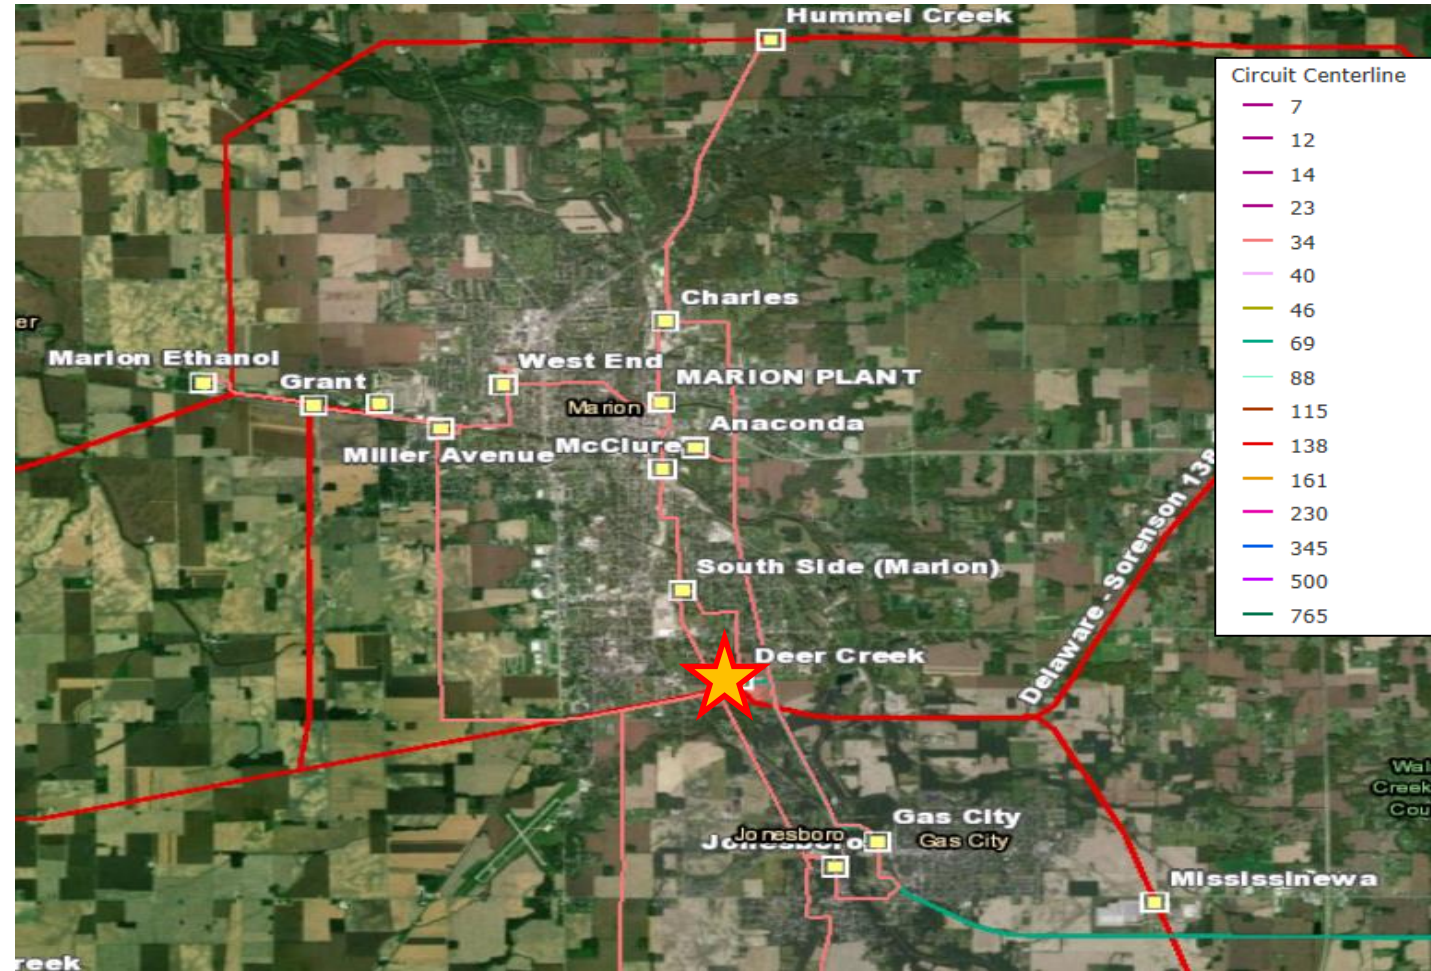
Deer Creek – Hummel Creek 34.5 kV (11 miles)

- 1940 wood crossarm construction (age based on age of station)
- Subject to 16 open A conditions
- Subject to 17 open B conditions
- In the past 10 years, 16 structures have had active maintenance performed. This is expected to increase as line ages.

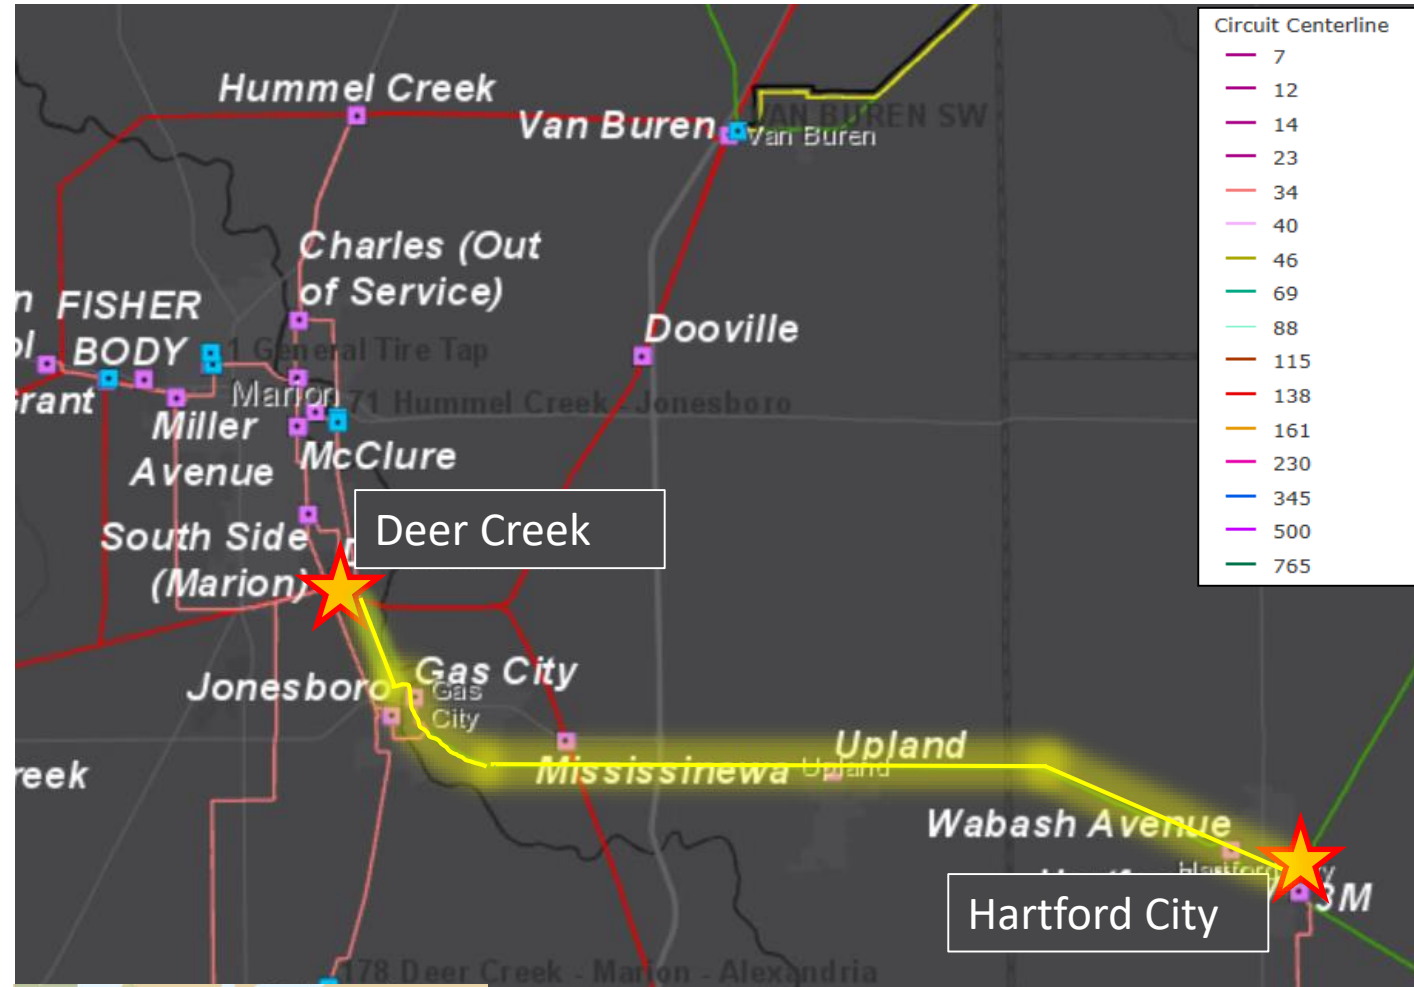
Deer Creek – Hartford City 69 kV (vintage 1967):

- Length: 17.67 Miles
- Original Construction Type: Wood pole structures with cross arm construction and vertical post insulators.
- Original Conductor Type:
 - 336.4 kCM ACSR 18/1 Merlin (18.17 mi, vintage 1967)
 - 3/0 Copper 7 (30COP) (2.24 mi, vintage 1967)
- Momentary/Permanent Outages: 21 total outages: 10 (Momentary), 11 (Permanent).
- 5 Year CMI: 67,818
- Number of open conditions: 4
 - Open conditions include: Cross arm or pole with split and woodpecker conditions and broken or missing ground lead wire.
- Based on the ground crew assessment roughly 28% of the structures had advanced levels of decay on the poles
- Total structure count: 378 with 366 dating back to original installation.

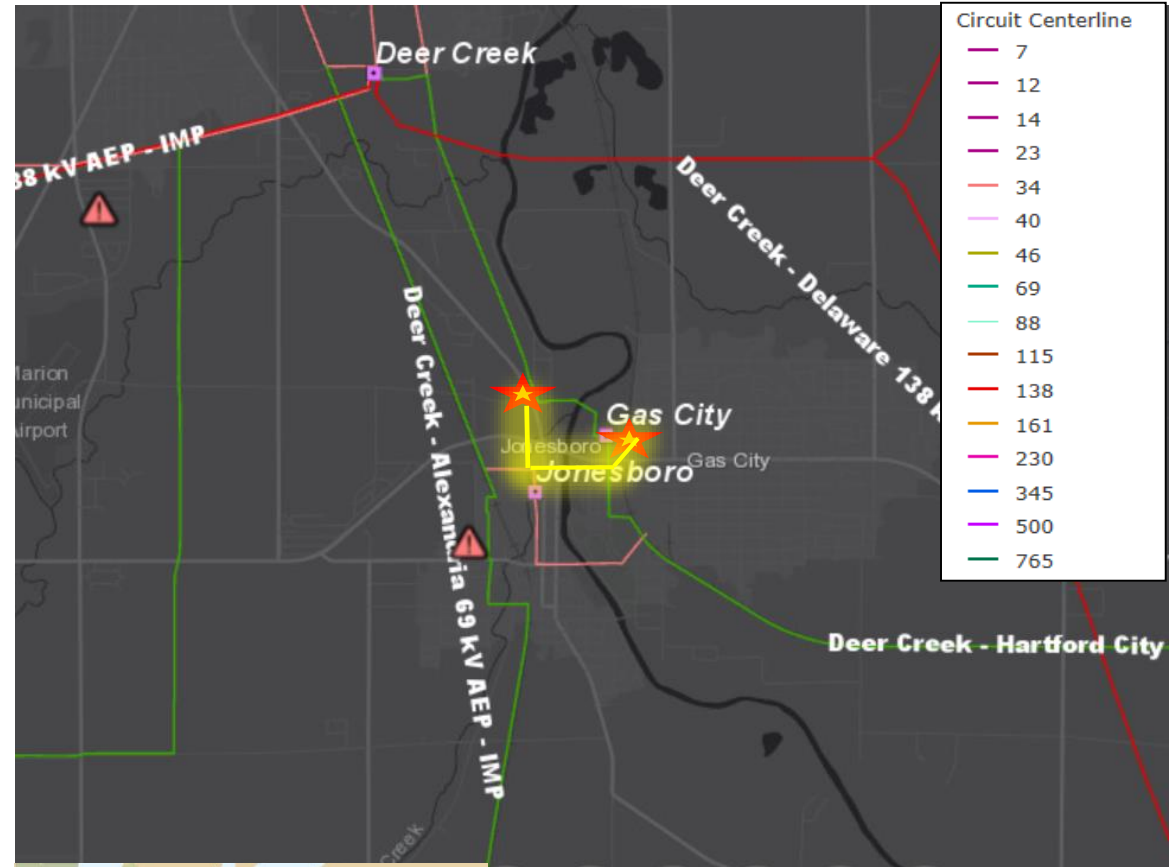
Jonesboro – Gas City 34.5 kV (vintage 1969):

- Length: 1.01 Miles
- Original Construction Type: Wood pole structures
- Original Conductor Type:
 - 336.4 ACSR 18/1 Merlin (0.65 mi, vintage 1969)
 - 3/0 Copper 7 (0.36 mi, vintage 1969)
- Number of open conditions: 12
 - Open conditions include: Cross arm or pole with split rot conditions, knee/vee brace with loose conditions, broken guy strain insulator and right of way encroaching buildings.
- Total structure count: 34 (original vintage)

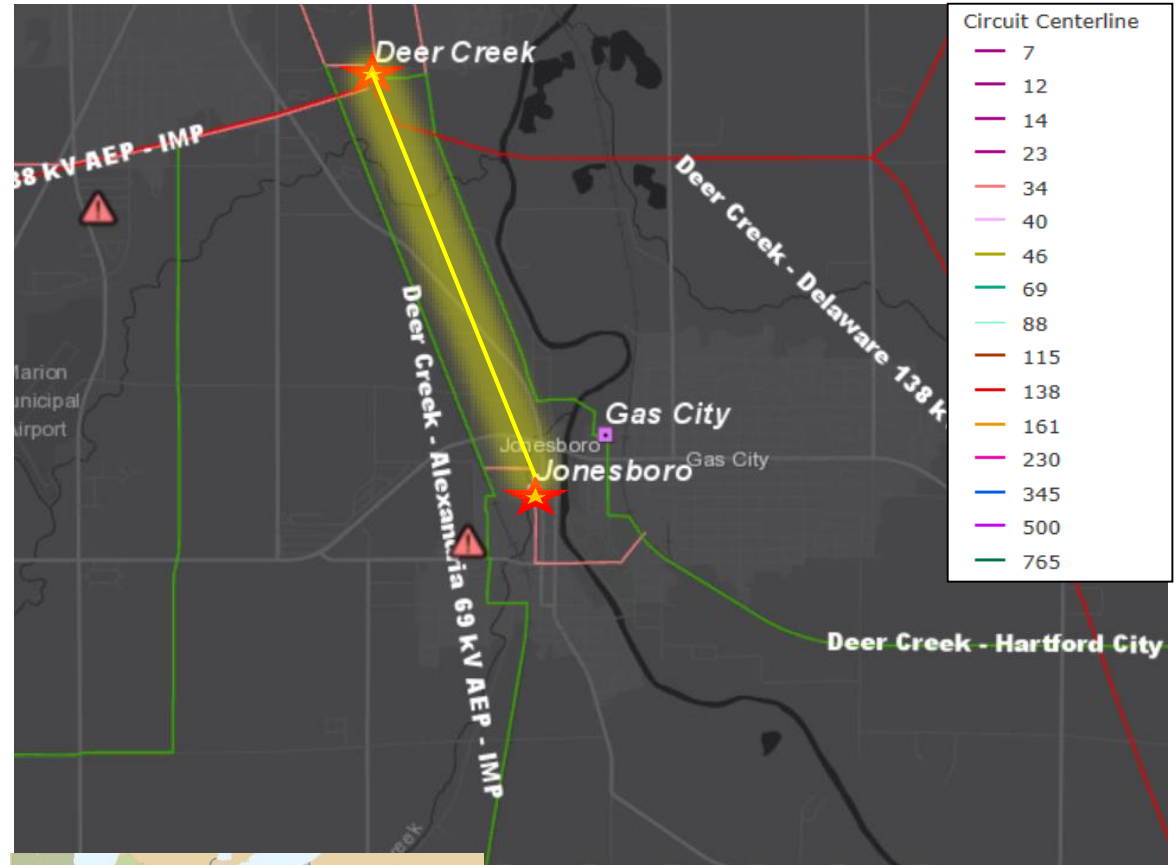
Deer Creek – Alexandria 34.5 kV (vintage 1968):

- Length: 2.19 Miles
- Original Construction Type: Wood pole structures
- Original Conductor Type:
 - 556.5 kCM ALUM/1250 19 Dahlia
- Number of open conditions: 7
 - Open conditions include: Cross arm or pole with rot top conditions, stolen ground lead wires and improperly installed shield wire.
- Total structure count: 61, with 60 dating back to original installation.

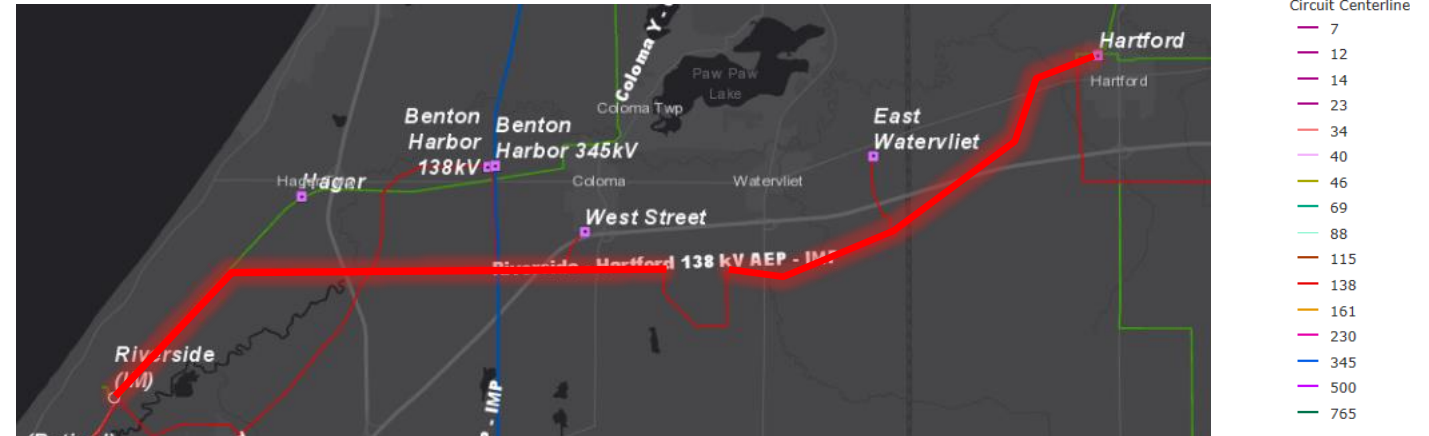
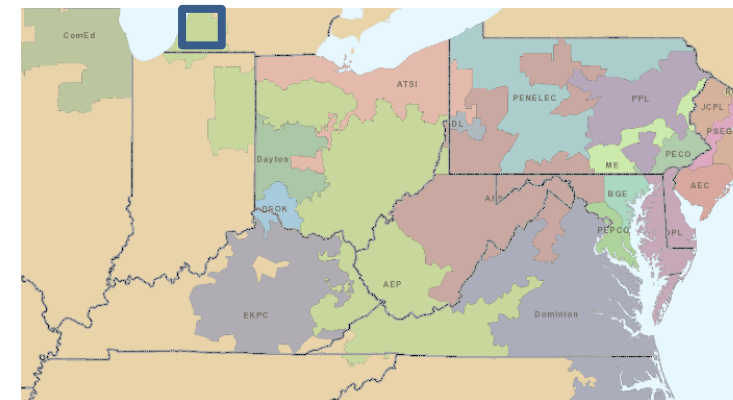
Riverside – Hartford 138kV line:

- 16.85 miles of mostly 1957 wood H-Frame construction
- Conductor is 397 MCM ACSR
- There are 48 structures with open conditions (36% of line). 40 of these are structure related affecting the crossarm, pole, or X-brace including rot, corrosion, cracked, woodpecker, and disconnected conditions.
- Additional assessment identified the following:
 - 15 structures were subject to some level of decay above normal weathering
 - 10 had crossarm decay
 - 9 had ground line decay
 - 4 had broken/flashed insulators
 - 64% of structures assessed had some level of decay

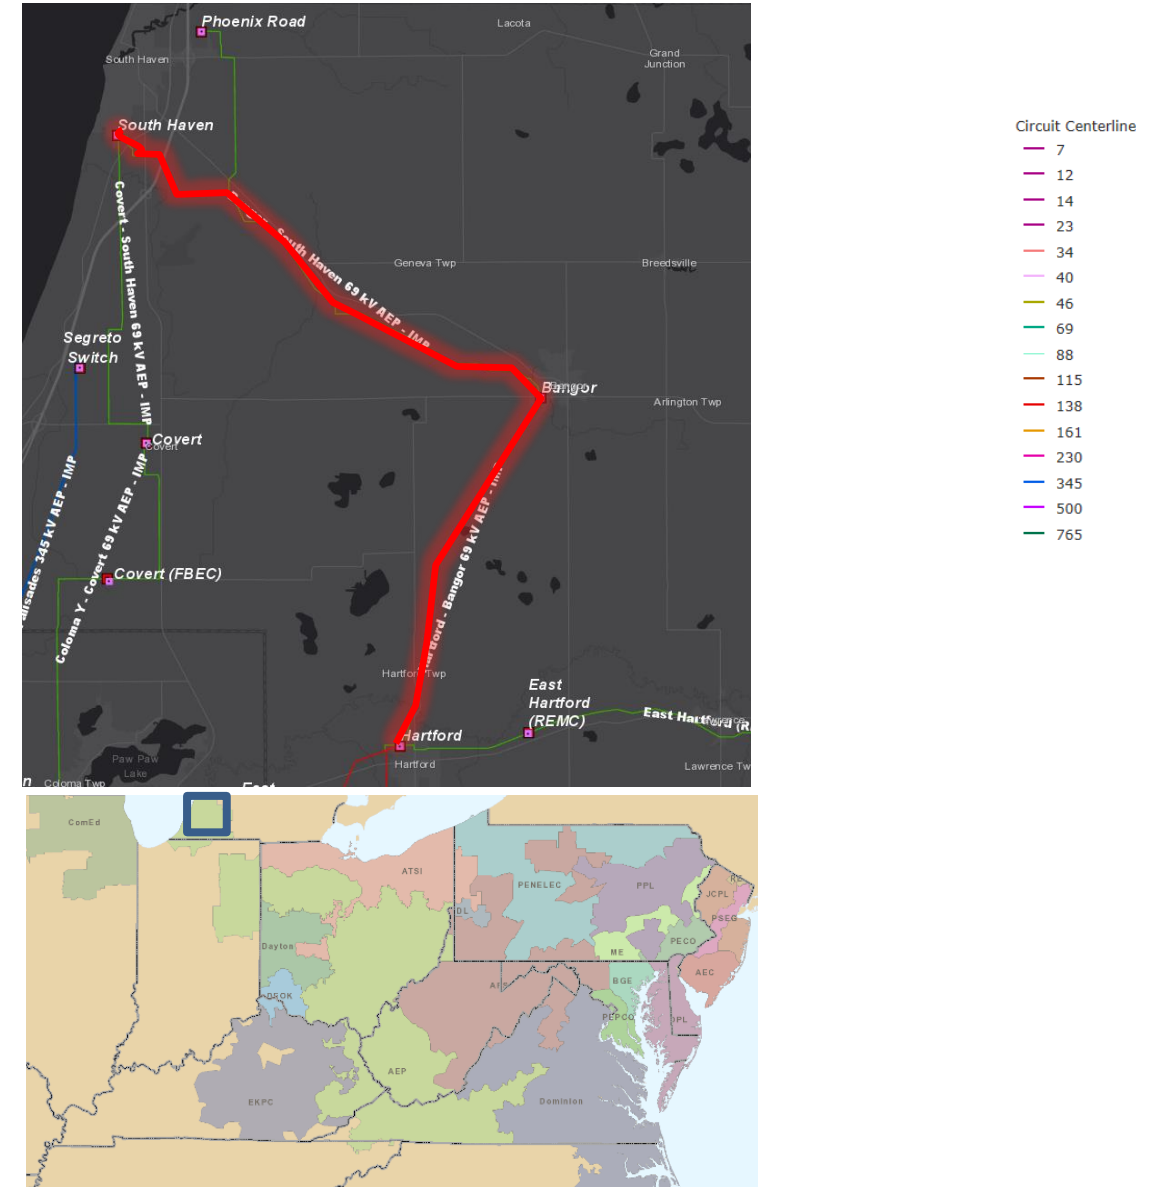
Hartford – South Haven 69kV line:

- 18.68 miles of mostly 1966 wood pole
- Conductor is 336.4 ACSR
- Since 2015 there have been 20 momentary and 4 permanent outages.
- 4,984,780 CMI from 2015-2020
- Structures fail NESC Grade B, AEP Strength requirements and ASCE strength requirements
- There are 90 structures with open conditions (29% of line). 52 of these are structure related including pole rot, split and woodpecker damage

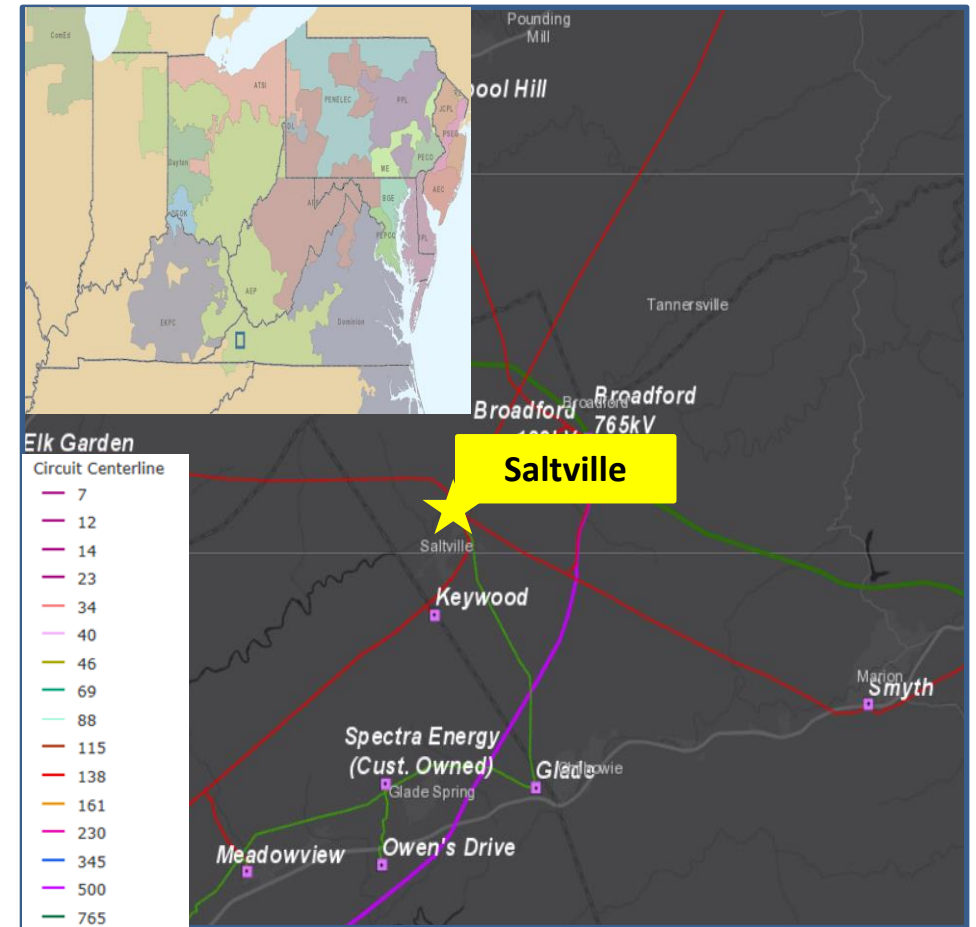
Circuit Breakers J (69 KV) Concerns:

- Circuit breaker J is 53 years old, CF-48-69-2500 type, oil filled breaker – which requires frequent maintenance. Oil spills are common and can result in significant environmental mitigation costs.
- This breaker has experienced 34 fault operations — exceeding manufacturer's recommended number of 10.
- There is no support for the CF family of circuit breakers and spare parts are obsolete, impossible to obtain.

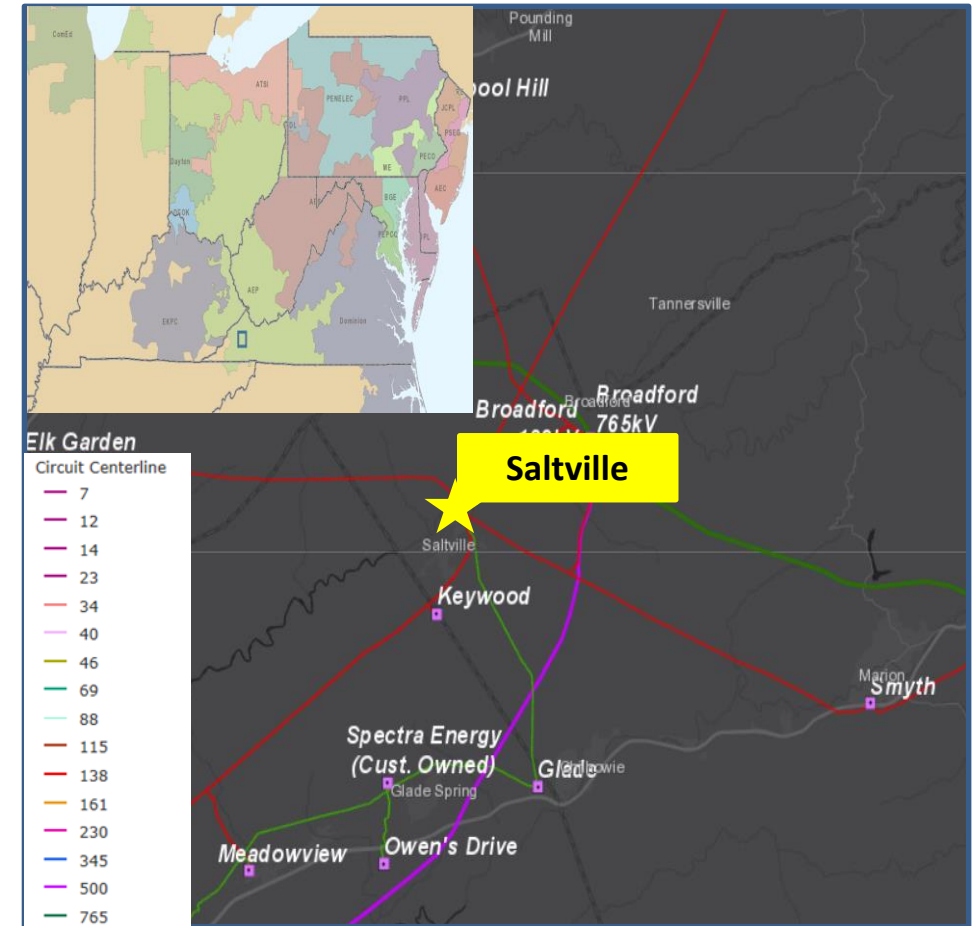
- Currently, 79 of the 95 relays are in need of replacement.
- There are 68 of the electromechanical, 6 static type and 5 legacy microprocessor relays — which have significant limitations with regards to fault data collection and retention.
