Sub Regional RTEP Committee: Western AEP Supplemental Projects

July 16, 2021

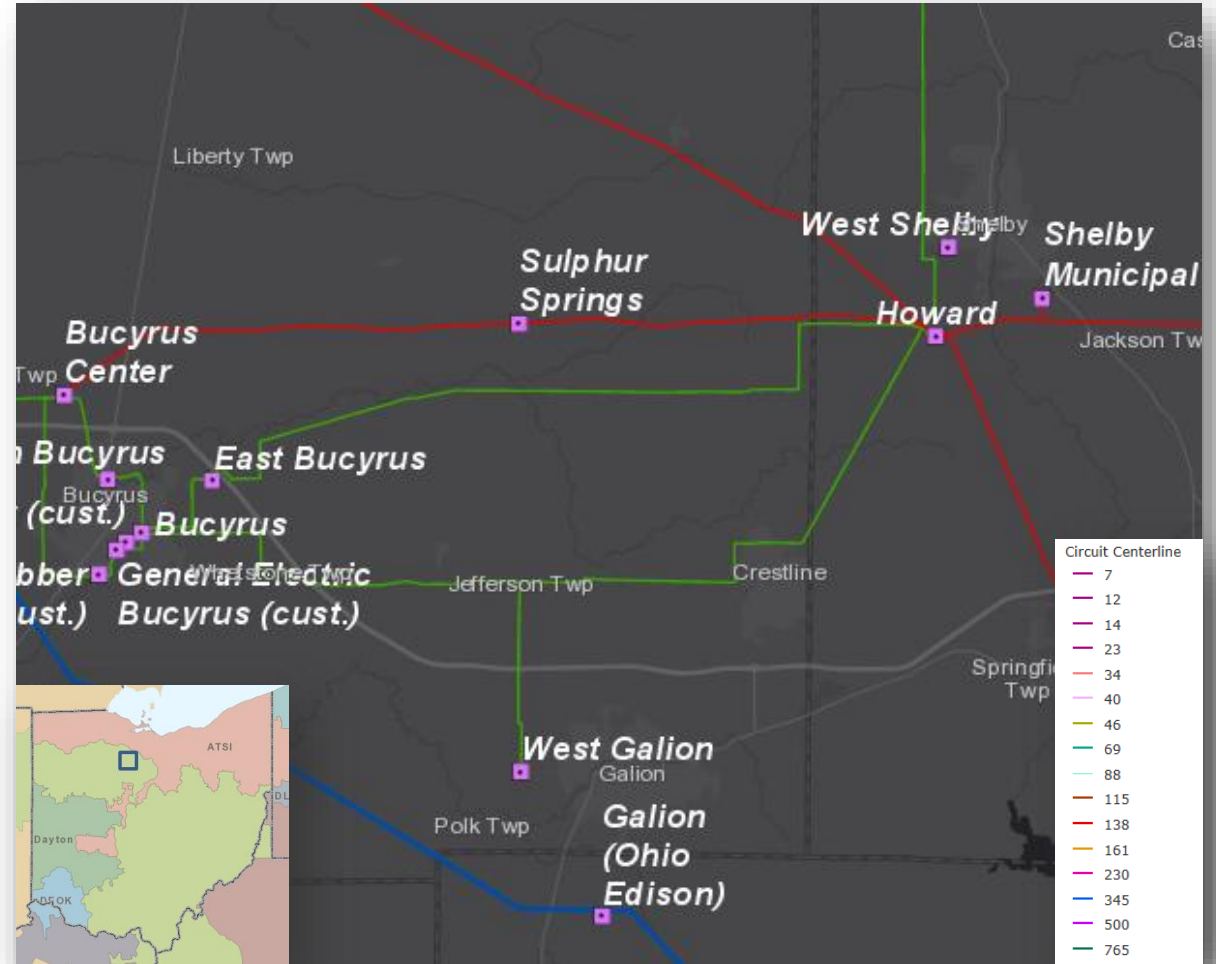
Line Name: Bucyrus – Howard No.1 69kV

- **Original Install Date (Age):** 1948
- **Length of Line:** 18.05 miles
- **Total structure count:** 413
- **Original Line Construction Type:** Wood
 - 14 % of structures rehabbed since installation
 - Wood Cross Arms
- **Conductor Type:** 3/0 Copper 7 conductor
- **Outage History (past 5 years)**
 - 7 momentary and 2 permanent outages with an average duration of 5.37 hours
 - CMI: 60,120
- **Condition Summary**
 - Number of open conditions by type / defects / inspection failures: 78
 - Ground lead wire missing, stolen or broken, structure related conditions affecting the cross arm or pole including rot, split or woodpecker holes, contaminated or broken insulator hardware
- Number of Customers at Risk: 331, 11.527 MVA
