Sub Regional RTEP Committee PJM Mid-Atlantic First Energy MAAC

March 25, 2019

Need Number: JCPL-2019-016 and 018

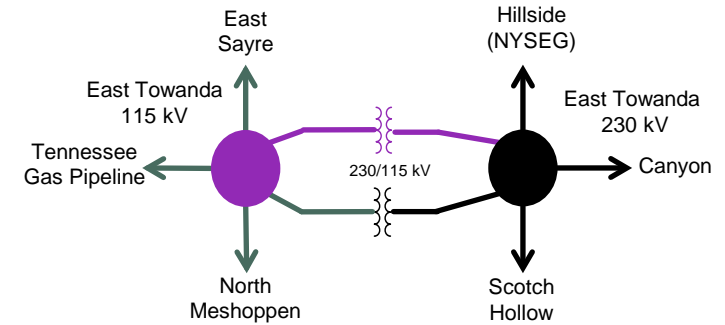
East Towanda #4 230/115 kV Transformer Replacement

- Replace the #4 230/115 kV transformer with a 230/115 kV 180/240/300 MVA transformer
- Replace substation conductor

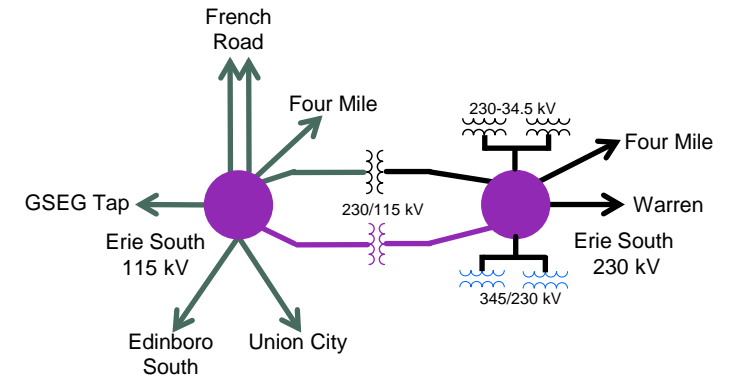
Erie South #6 230/115 kV Transformer Replacement

- Replace the #6 230/115 kV transformer with a 230/115 kV 180/240/300 MVA transformer
- Replace the 230 kV circuit switcher with a circuit breaker

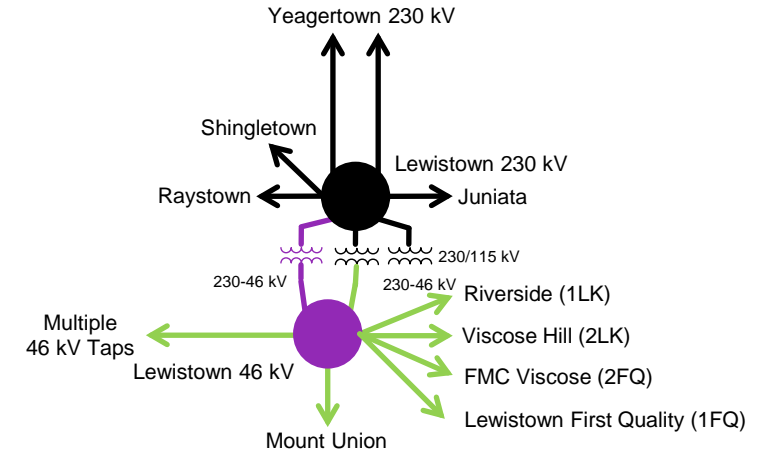
Replace Lewistown #1 230/115-46 kV Transformer

- Replace the #1 230/115-46 kV transformer and with 230-46 kV 60/80/100 MVA transformer
- Replace relaying and disconnects switches
- Replace overdutied 46 kV breakers due to transformer replacement
(FMC Viscose (2FQ), Lewistown First Quality (1FQ), and #1 Transformer breakers)

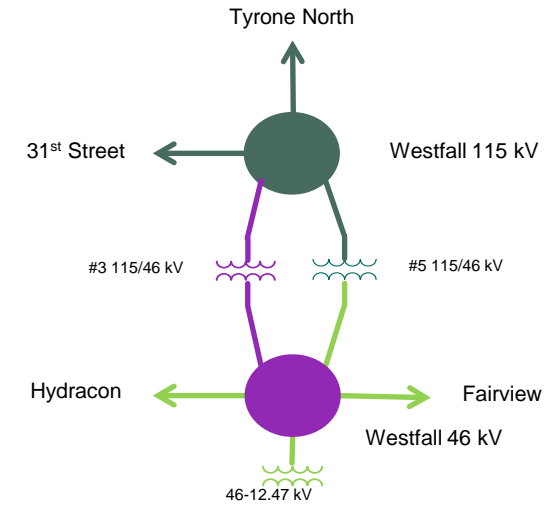
Westfall #3 and #4 115/46 kV Transformer Replacements
