SRRTEP Committee Western AEP Supplemental Projects

December 18, 2019

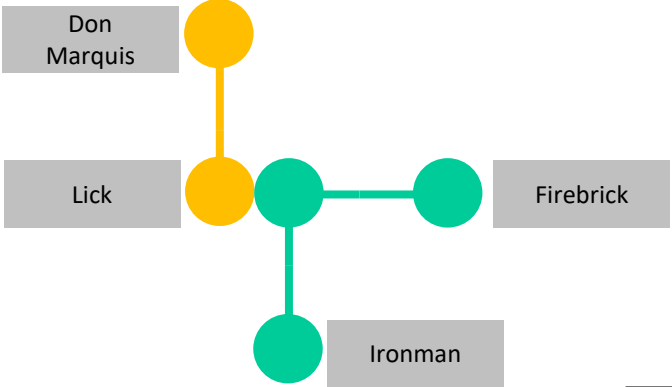
Existing:

- At Lick station, replace the three existing 138/69-12kV transformers with two 138/12 kV transformers and one 138/69 kV transformer. The 69 kV bus will be rebuilt in the clear within the station due to constructability concerns. Three 69kV 40kA, 3000A CBs will be installed on the low side of transformer and 69 kV line exits. An additional 138kV 40kA, 3000A CB will be added at the station to separate the 138 kV circuits towards the City of Jackson and Don Marquis. **Estimated Cost: \$8.3M**
- Relocate the Don Marquis – Lick 138 kV circuit associated with the station work at Lick. **Estimated Cost: \$0.7M**
- Relocate the Firebrick – Lick 69 kV circuit associated with station work at Lick. **Estimated Cost: \$0.8M**
- Relocate the Ironman – Lick 69 kV circuit associated with station work at Lick. **Estimated Cost: \$0.5M**

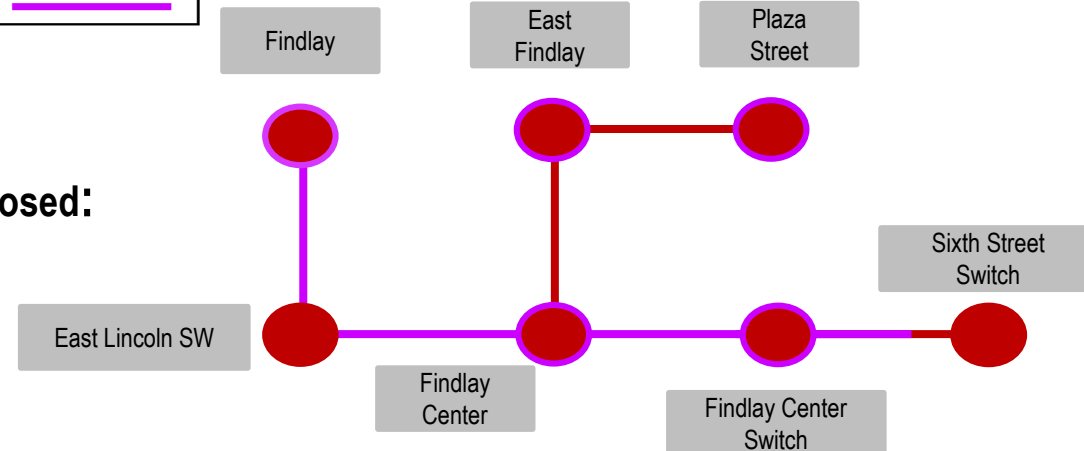
Proposed:

- At Plaza Street station, replace 34.5kV CB-A with 69kV (2000A / 40kA) and remove CB-A bypass switch. **Estimated Cost: \$1.3M**
- At Findlay station, replace CB's A, B, D, E with 69kV breakers (2000A / 40kA) and replace Circuit Switcher AA with 69kV (2000A / 25kA). **Estimated Cost: \$4.0M**

- At Findlay Center station, replace CB's A, B, C, D with 69kV breakers (2000A / 40kA), add an additional 69kV breaker (2000A / 40kA) and change bus to ring configuration, and replace Circuit Switcher AA with 69kV (1200A / 25kA). **Estimated Cost: \$5.0M**

- At Findlay Center Sw, replace two-way switch with three-way 69kV POP switch. **Estimated Cost: \$0.3M**
- At East Findlay, replace existing switch with three-way 69kV POP switch. **Estimated Cost: \$0.6M**

- Rebuild 1.6 miles of double circuit section of the New Liberty – Findlay Center 34.5 kV line asset. **Estimated Cost: \$8.6M**
- Replace 4 structures on double circuit section of New Liberty – Findlay 34.5 kV line asset. **Estimated Cost: \$1.3M**

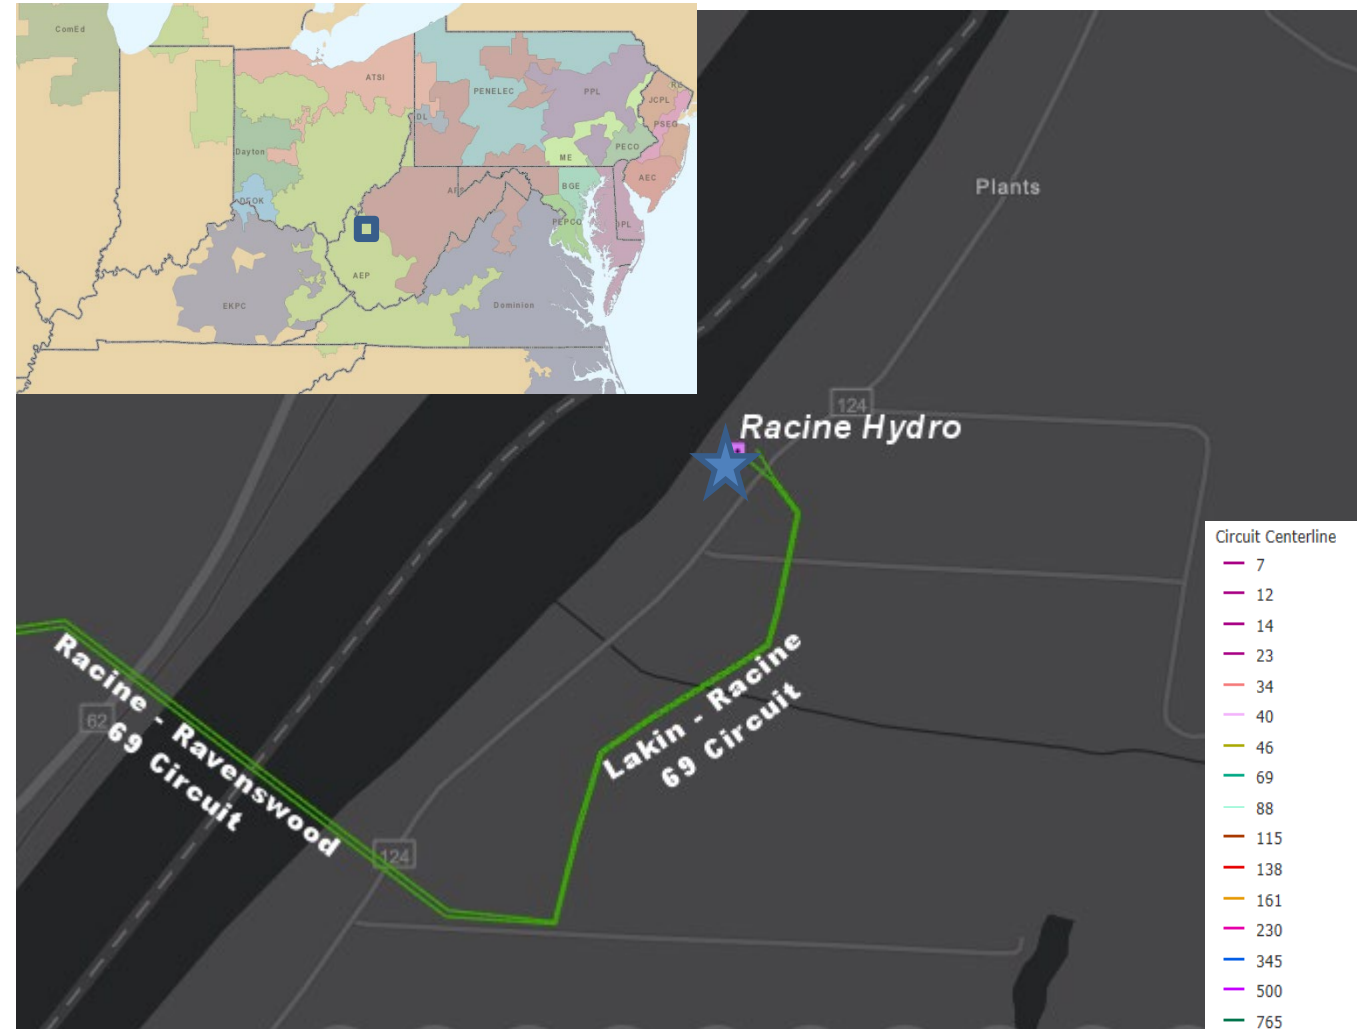
Racine 69 kV circuit breaker B

- CG-48 oil type breakers that was manufactured in 1980.
- Oil breakers are more difficult to maintain as oil spills have the potential to occur during maintenance which can be an environmental and safety hazard.
- Experienced 43 fault operations, exceeding the manufacturer's designed number of fault operations of 10.

Racine Station: Replace existing 69 kV circuit breaker with a new 69 kV 40 kA 3000 A circuit breaker. Associated remote end work at Ravenswood station. **Estimated Cost: \$1.4M**

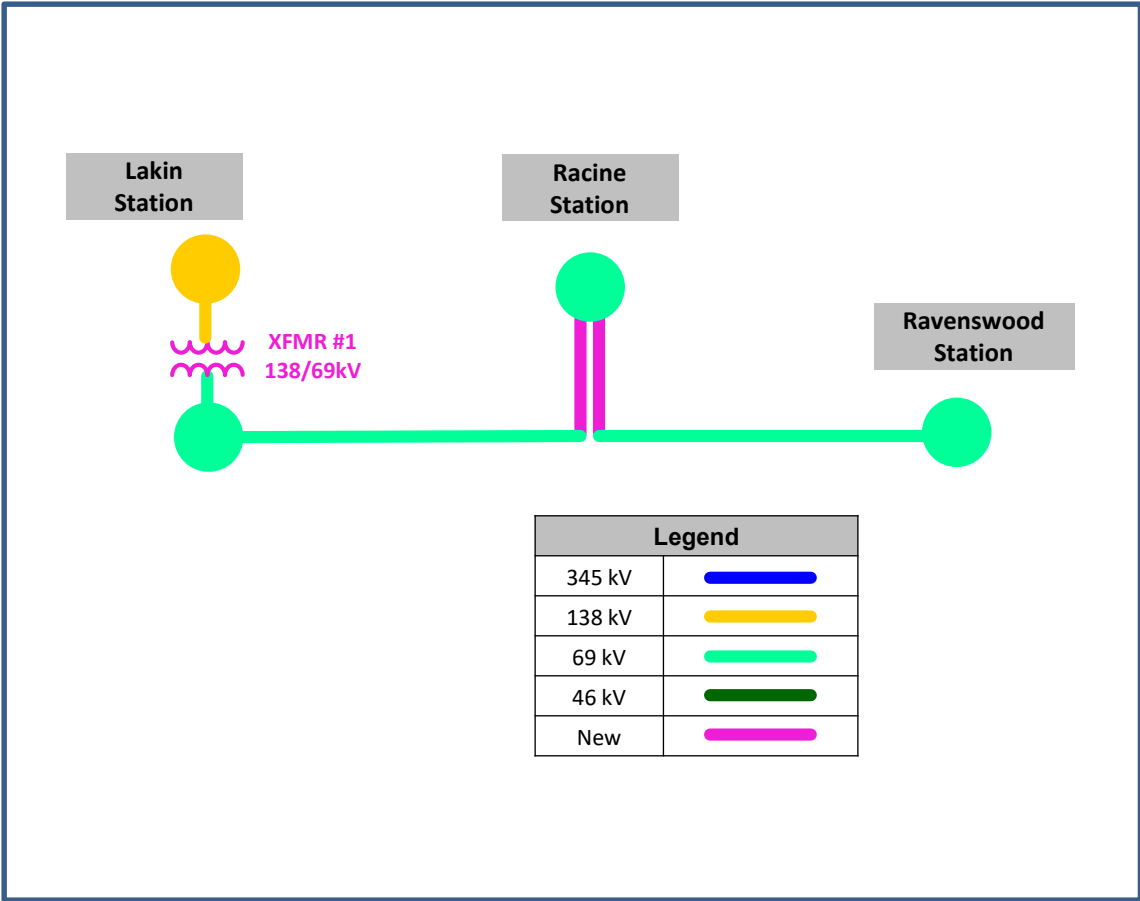
Lakin Station: Remove existing 138 kV line switches and MOAB/Gr. Sw. Install 4 new 138 kV 40 kA 3000 A circuit breakers in a ring configuration. Replace existing 138/69 kV 90 MVA XFR #1 with a new 138/69 kV 90 MVA XFR. Replace existing 69 kV CB-F with a new 69 kV 40 kA 3000 A circuit breaker. Associated remote end work at Sporn, Gavin and Point Pleasant Stations. **Estimated Cost: \$14.5M**

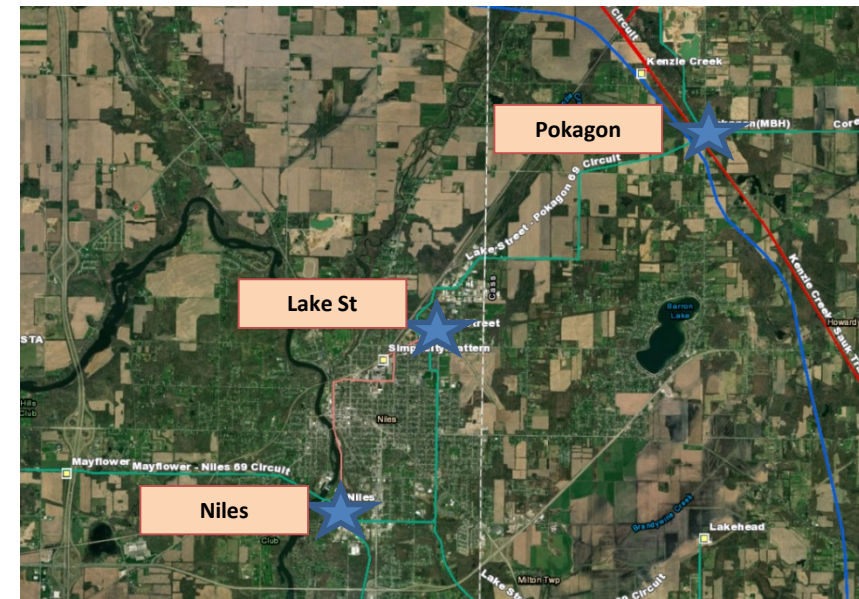
- CBs J, E, and H are oil filled breakers without oil containment
- Fault operations: CB E(28), CB H(61) - Recommended (10)

- CBs A and H are oil filled breakers without oil containment
- CB H is a GE FK type which are known to fail violently
- Fault operations: CB A(24), CB H(13) – Recommended (10)
- Transformer 1 – 1969 vintage
 - CO2 IEEE level 3
 - Moisture level high and rising
 - Wood tie supports

Niles Station

- CBs A, B, M, and N are oil filled breakers without oil containment
- CB M and CB N are GE FK type which are known to fail violently
- Fault operations: CB A(30), CB B(42), CB N(21) – Recommended (10)
- Transformer 2 – 1969 vintage
 - CO2 IEEE level 3
 - Moisture level high and rising
 - Wood tie supports
