Sub Regional RTEP Committee: Western AEP Supplemental Projects

December 18, 2020

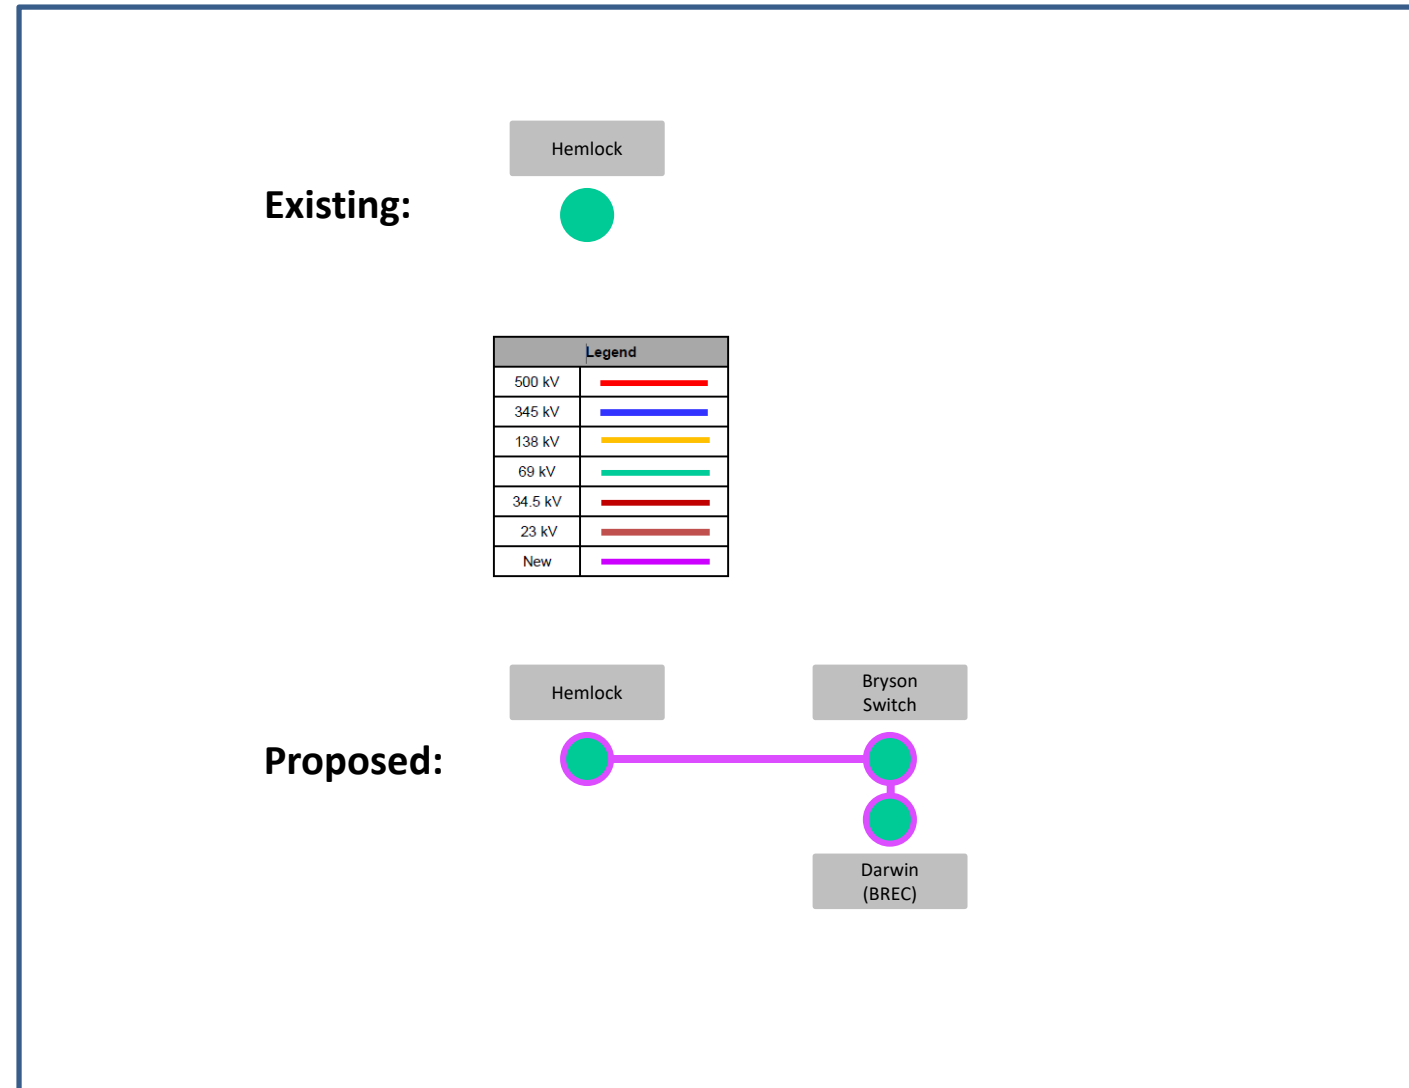
Install a greenfield 3-way 69 kV 1200 A phase over phase switch (Bryson Switch) with Auto-Sectionalizing, MOABs, and SCADA to serve the new requested delivery point.

Install metering at the proposed customer station. **Estimated Cost: \$0.7M**

Build a ~4.3 miles of greenfield single circuit 69kV transmission line between Hemlock – Bryson Switch with 556 ACSR conductor. **Estimated Cost: \$9.4M**

At Hemlock station, install a new 69kV 3000 A 40kA circuit breaker towards Bryson Switch. **Estimated Cost: \$1.1M**

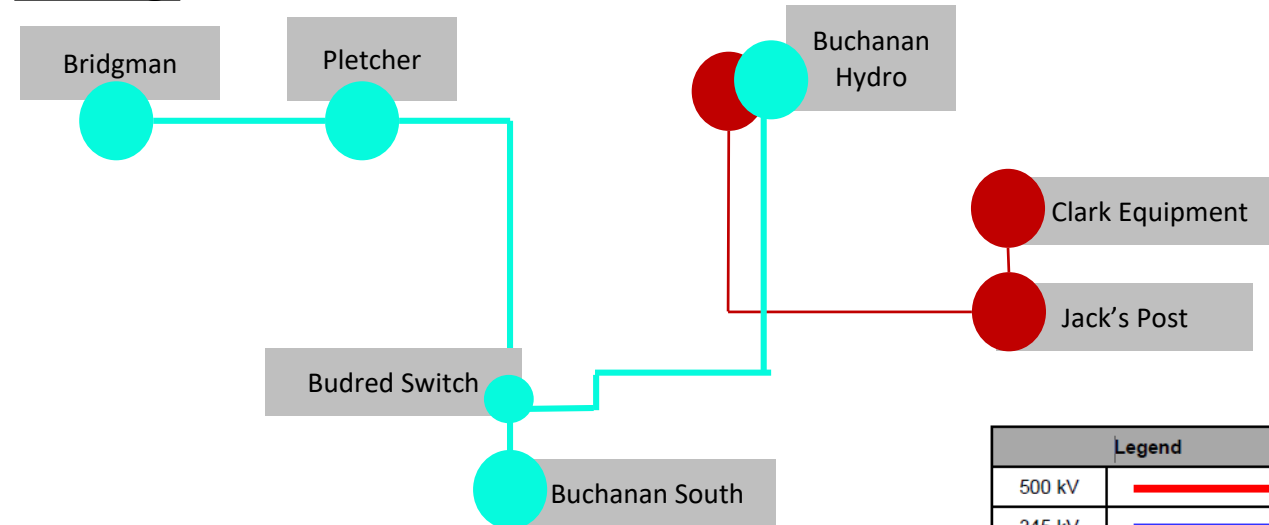
Existing:

Install new 69/34.5kV Bucktown station to replace Buchanan Hydro station. Install new 69/34.5kV transformer with (2) 34.5kV line breakers and a (4) 69kV breaker ring bus. **Estimated Cost: \$10.4M**

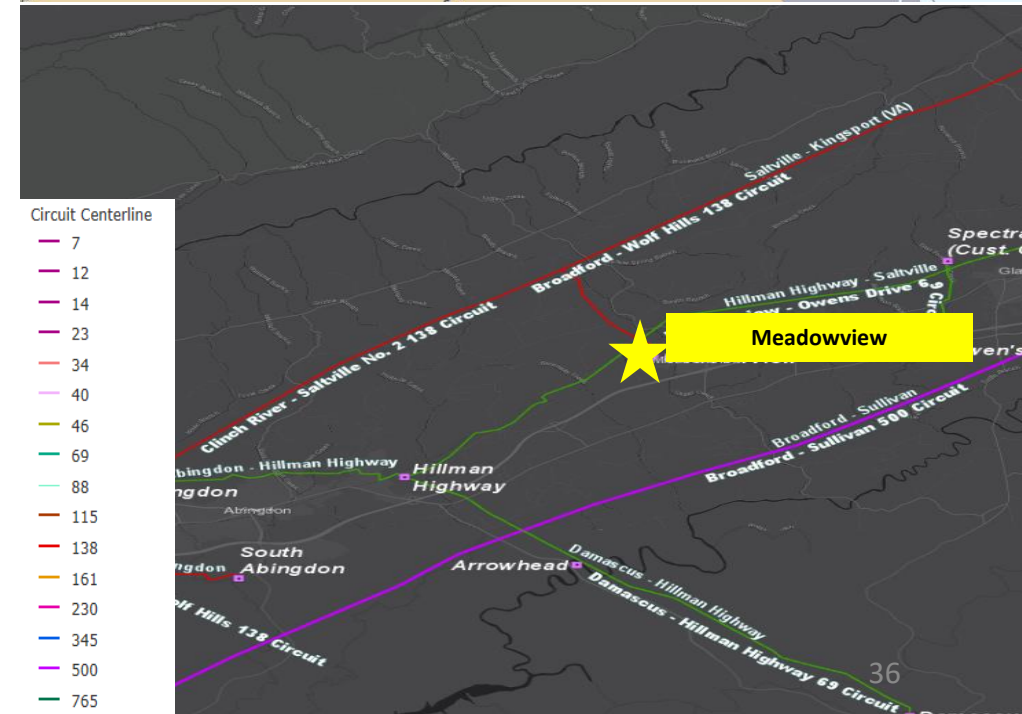
AEP Transmission Zone: Supplemental Washington, Virginia

- Circuit Breakers F and G are 23 years old, 72PM31-20 type, SF6 filled breakers.
- Circuit Breakers F and G have experienced 88 and 72 total fault operations, respectively, exceeding manufacturer’s recommended number full fault operations of 6.
- Circuit breakers of this type across the AEP system have had reports of moisture ingress into the breaker tank, which leads to increased maintenance and a higher risk of failure.
- This model type of breakers have experienced five catastrophic failures.
- There are documented issues with failures to close due to burned up coils, and 98 malfunction records related to SF6 gas leaks.

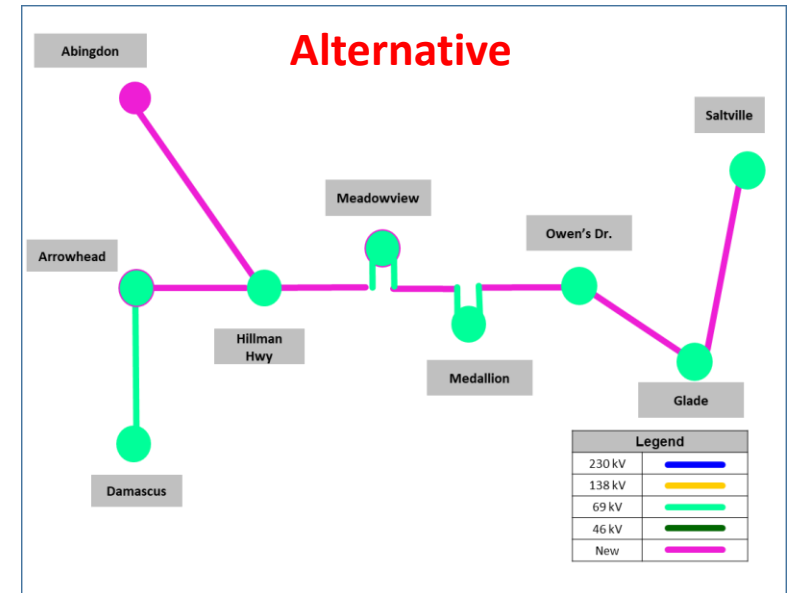
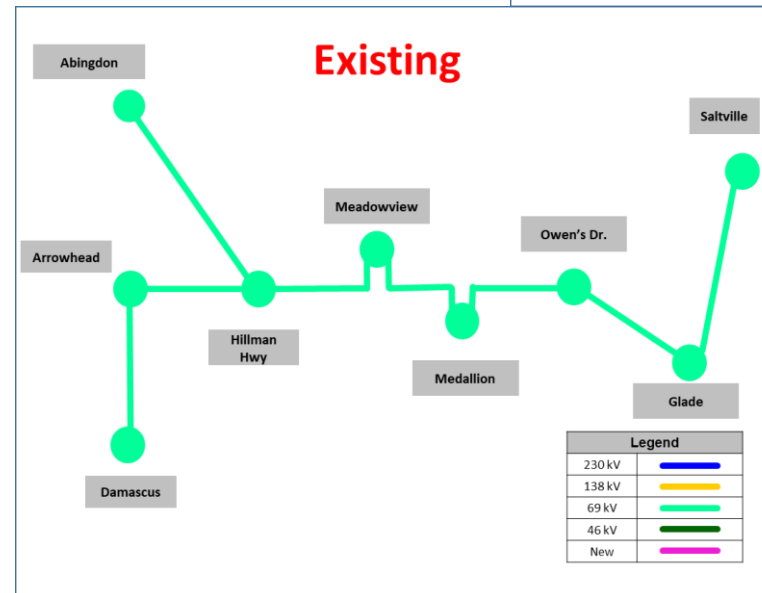
Solution will be worked in conjunction with baseline project B3278, which will replace the Meadowview transformer.
