Subregional RTEP Committee - Western FirstEnergy Supplemental Projects

November 15, 2024

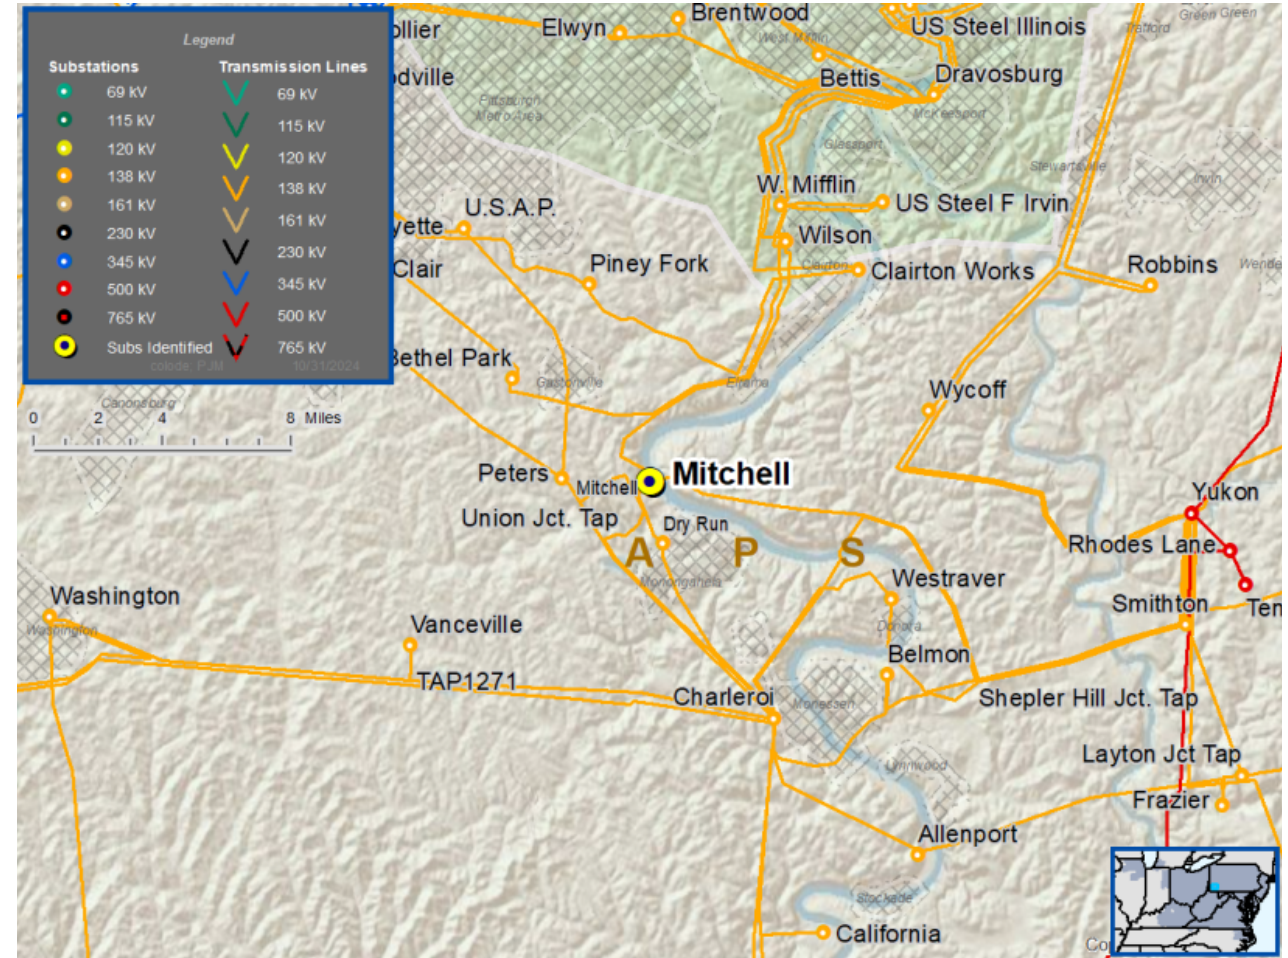
The Charleroi – Mitchell – Yukon (Shepler Hill Jct) 138 kV Line needs to be rerouted off the Mitchell Plant roof.
